**THE COURTYARD**  
**VIEW ANALYSIS**  
January 2024

**PRESENTED BY:**  
SIGNAL VENTURES LLC  
Attachment B

**The Courtyard – View Analysis**

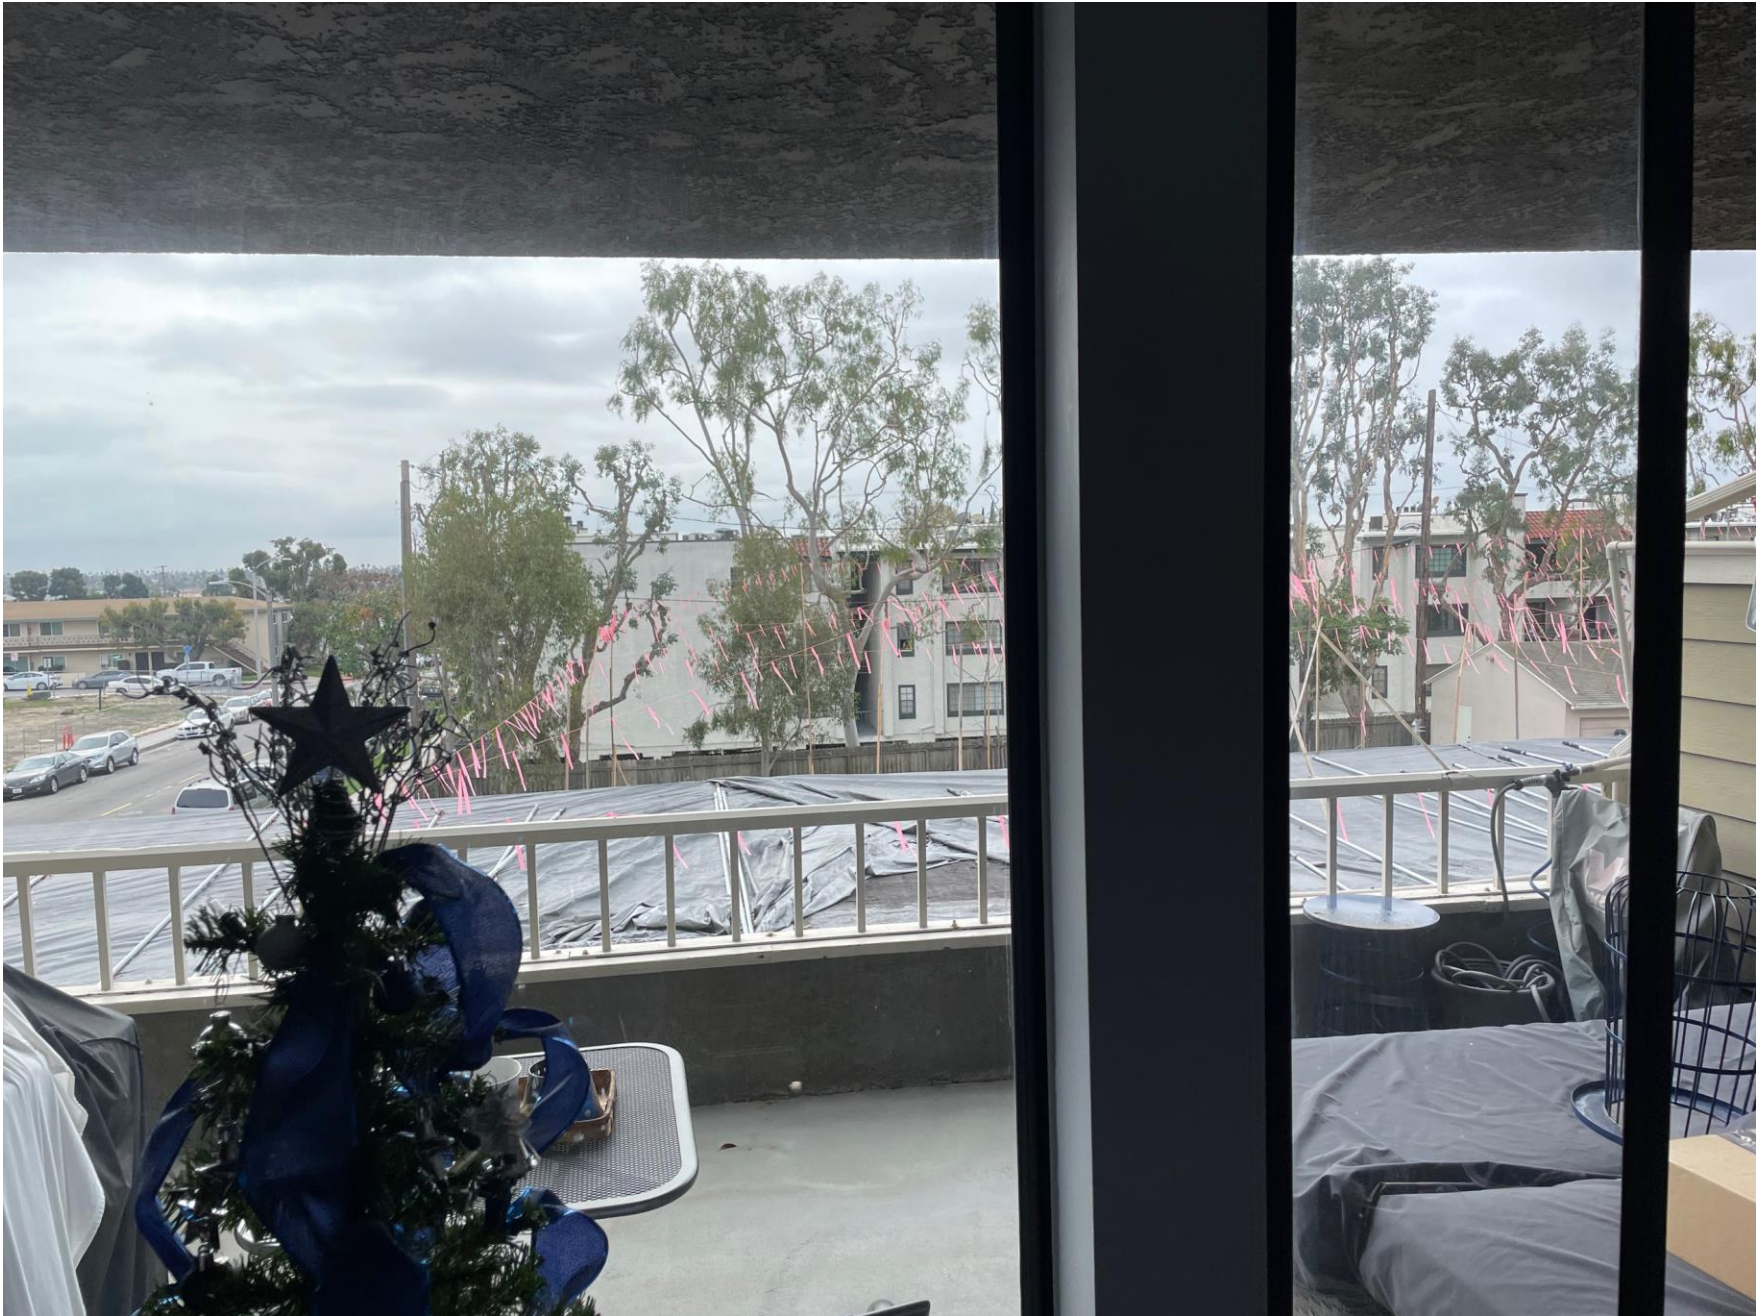
Living Room

As designed, The Courtyard project protects the expansive sky view which is the primary attribute of the unit while partially obscuring the view of the condominium and trees across the site.

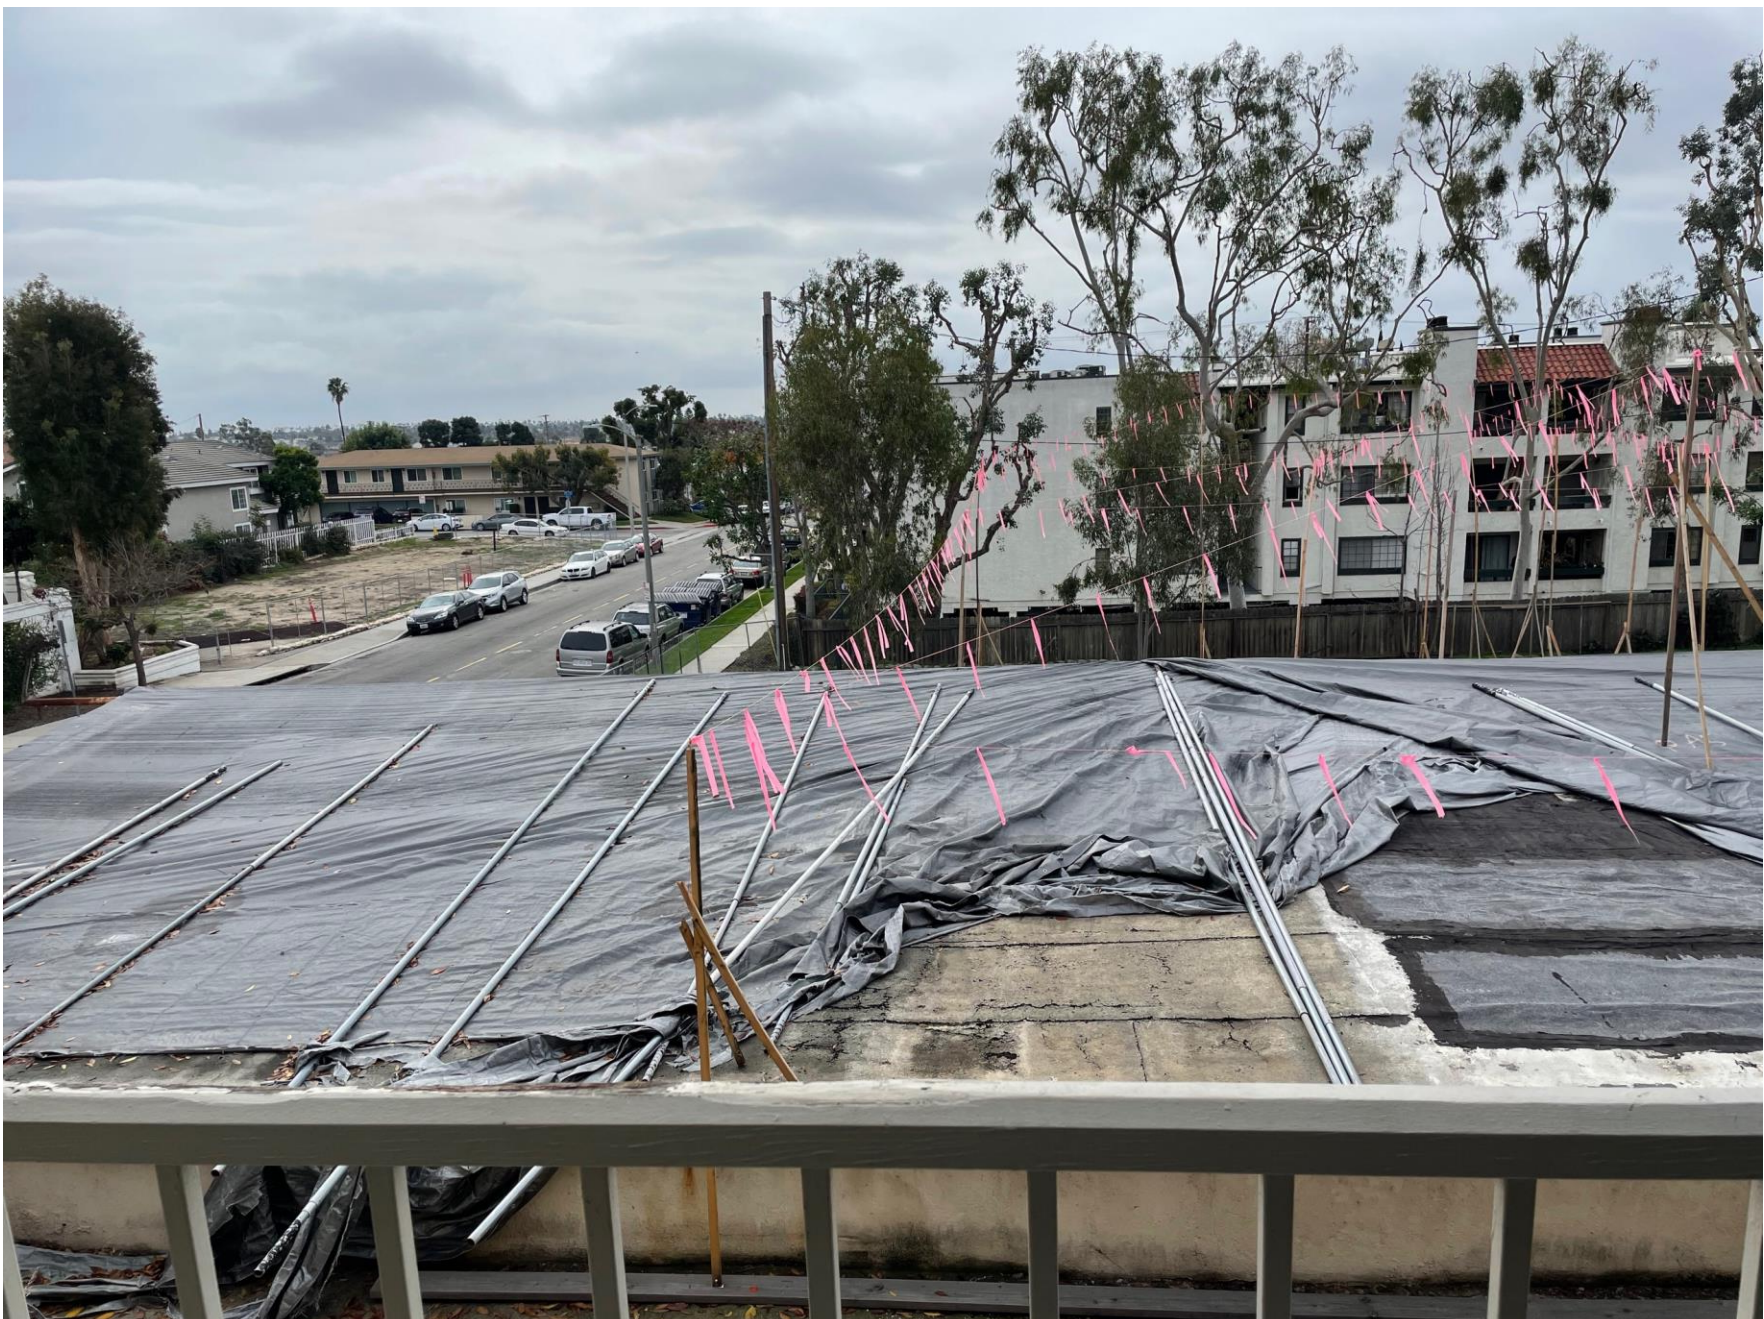
Balcony (middle)

<b>View Description</b>	<b>View Policy (Section 3.D)</b>		<b>View Designation</b>
1	Facing South / Outside Left-hand View from Balcony	Only View in Structure	No	Secondary. While this is the most important view of the unit, it is neither the only view nor is it of a unique landmark. Per the Signal Hill view policy; a viewing area shall be designated a “primary view area” if two or more conditions exist. NO IMPACT
		Most Important View	Yes	
		Subject of View is Unique Landmark	No	
2	Facing South & Southeast / Doorway at Right-hand View from Balcony	Only View in Structure	No	Secondary. NO IMPACT
		Most Important View	No	
		Subject of View is Unique Landmark	No	
3	Facing South / Inside of Living Room looking South	Only View in Structure	No	Secondary. NO IMPACT
		Most Important View	No	
		Subject of View is Unique Landmark	No

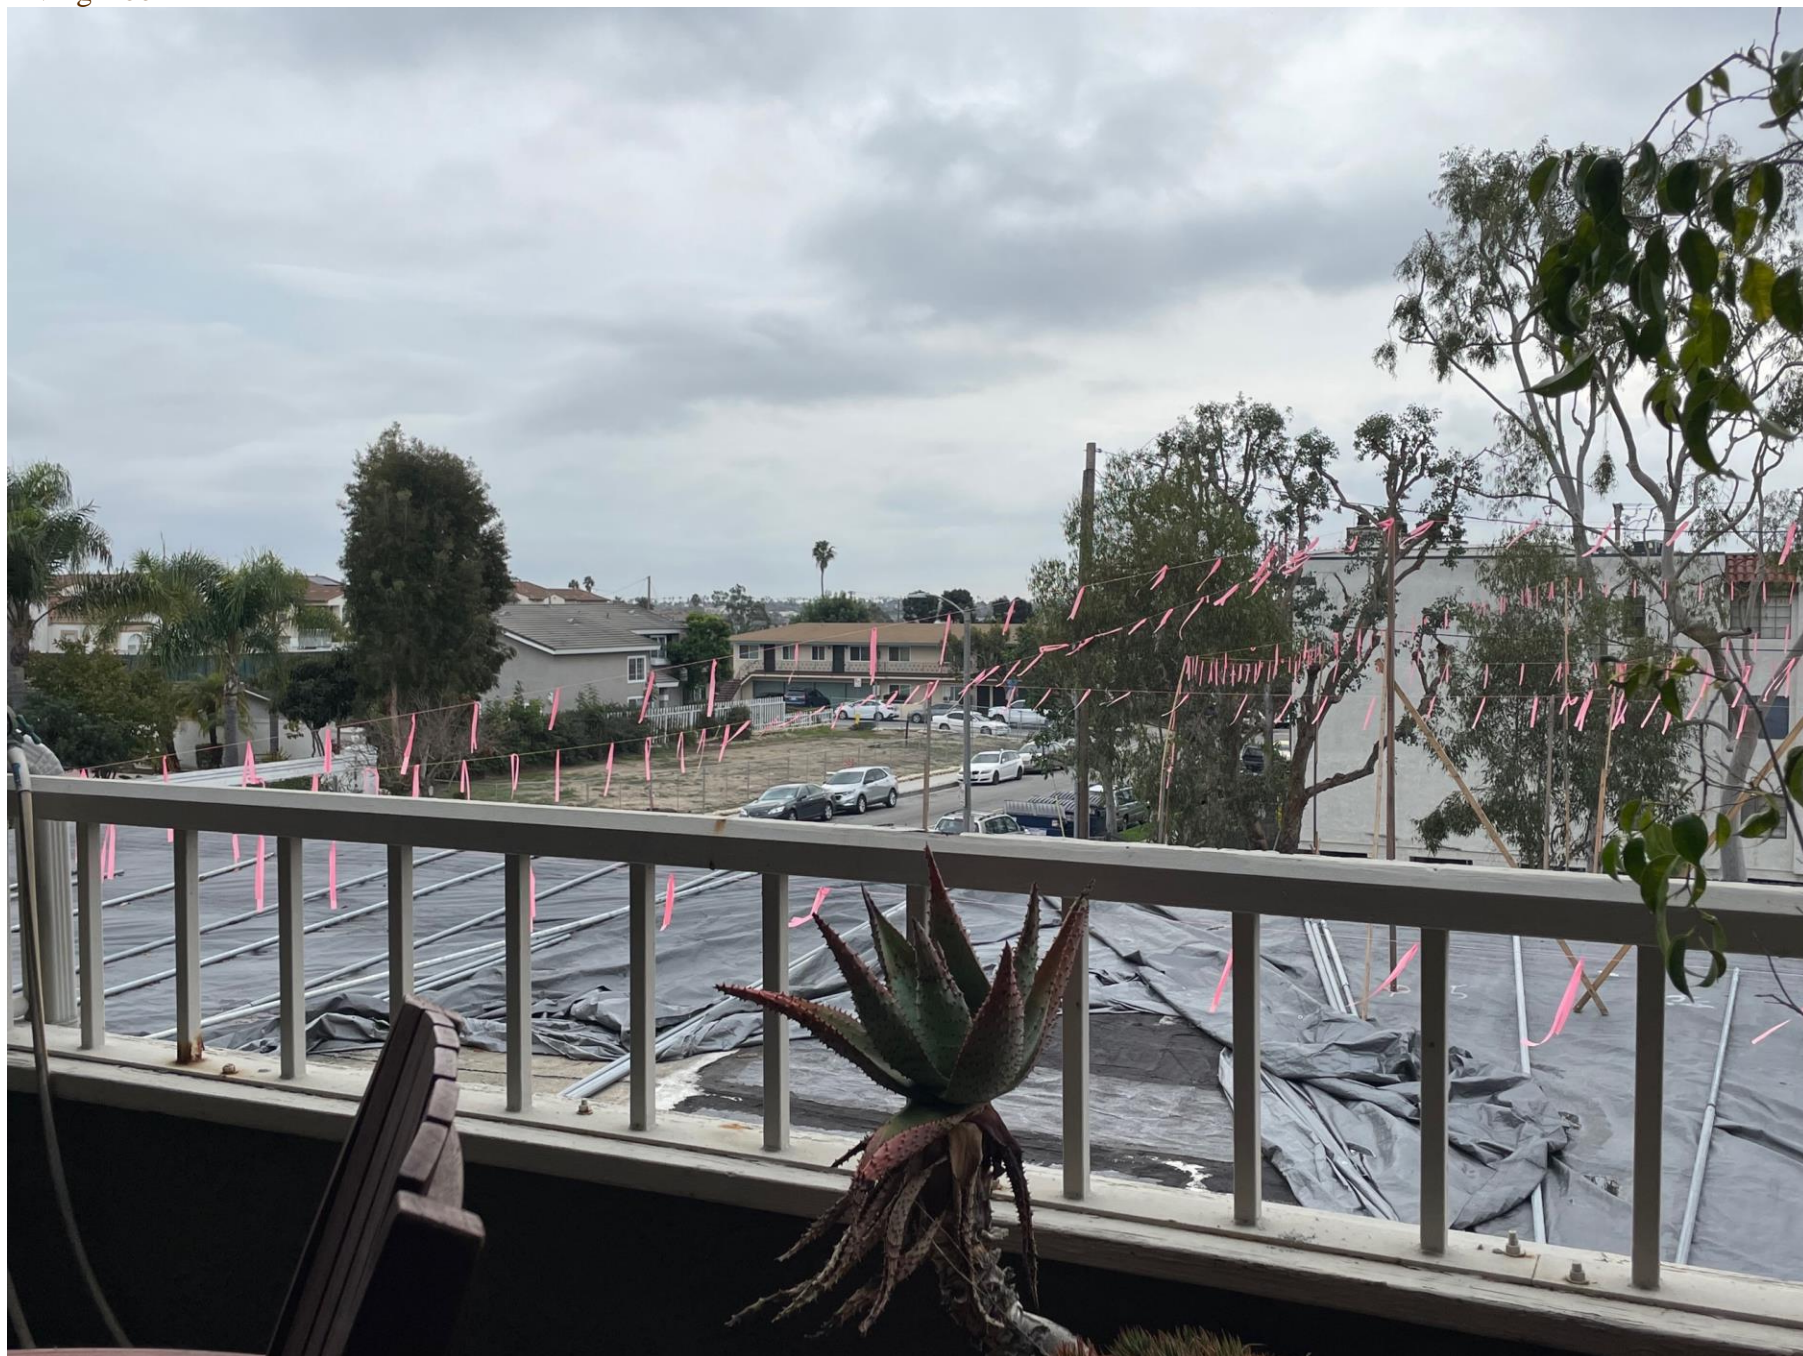
<b>View Description</b>	<b>View Policy (Section 3.D)</b>		<b>View Designation</b>
1	Facing Southeast from Western Edge of Balcony	Only View in Structure	No	Secondary. NO IMPACT
		Most Important View	No	
		Subject of View is Unique Landmark	No	
2	Facing Southeast from Middle of Balcony	Only View in Structure	No	Secondary. While this is the most important view of the unit, it is neither the only view nor is it of a unique landmark. Per the Signal Hill view policy; a viewing area shall be designated a “primary view area” if two or more conditions exist. NO IMPACT
		Most Important View	Yes	
		Subject of View is Unique Landmark	No	
3	Facing South from middle of of Balcony	Only View in Structure	No	Secondary. NO IMPACT
		Most Important View	No	
		Subject of View is Unique Landmark	No

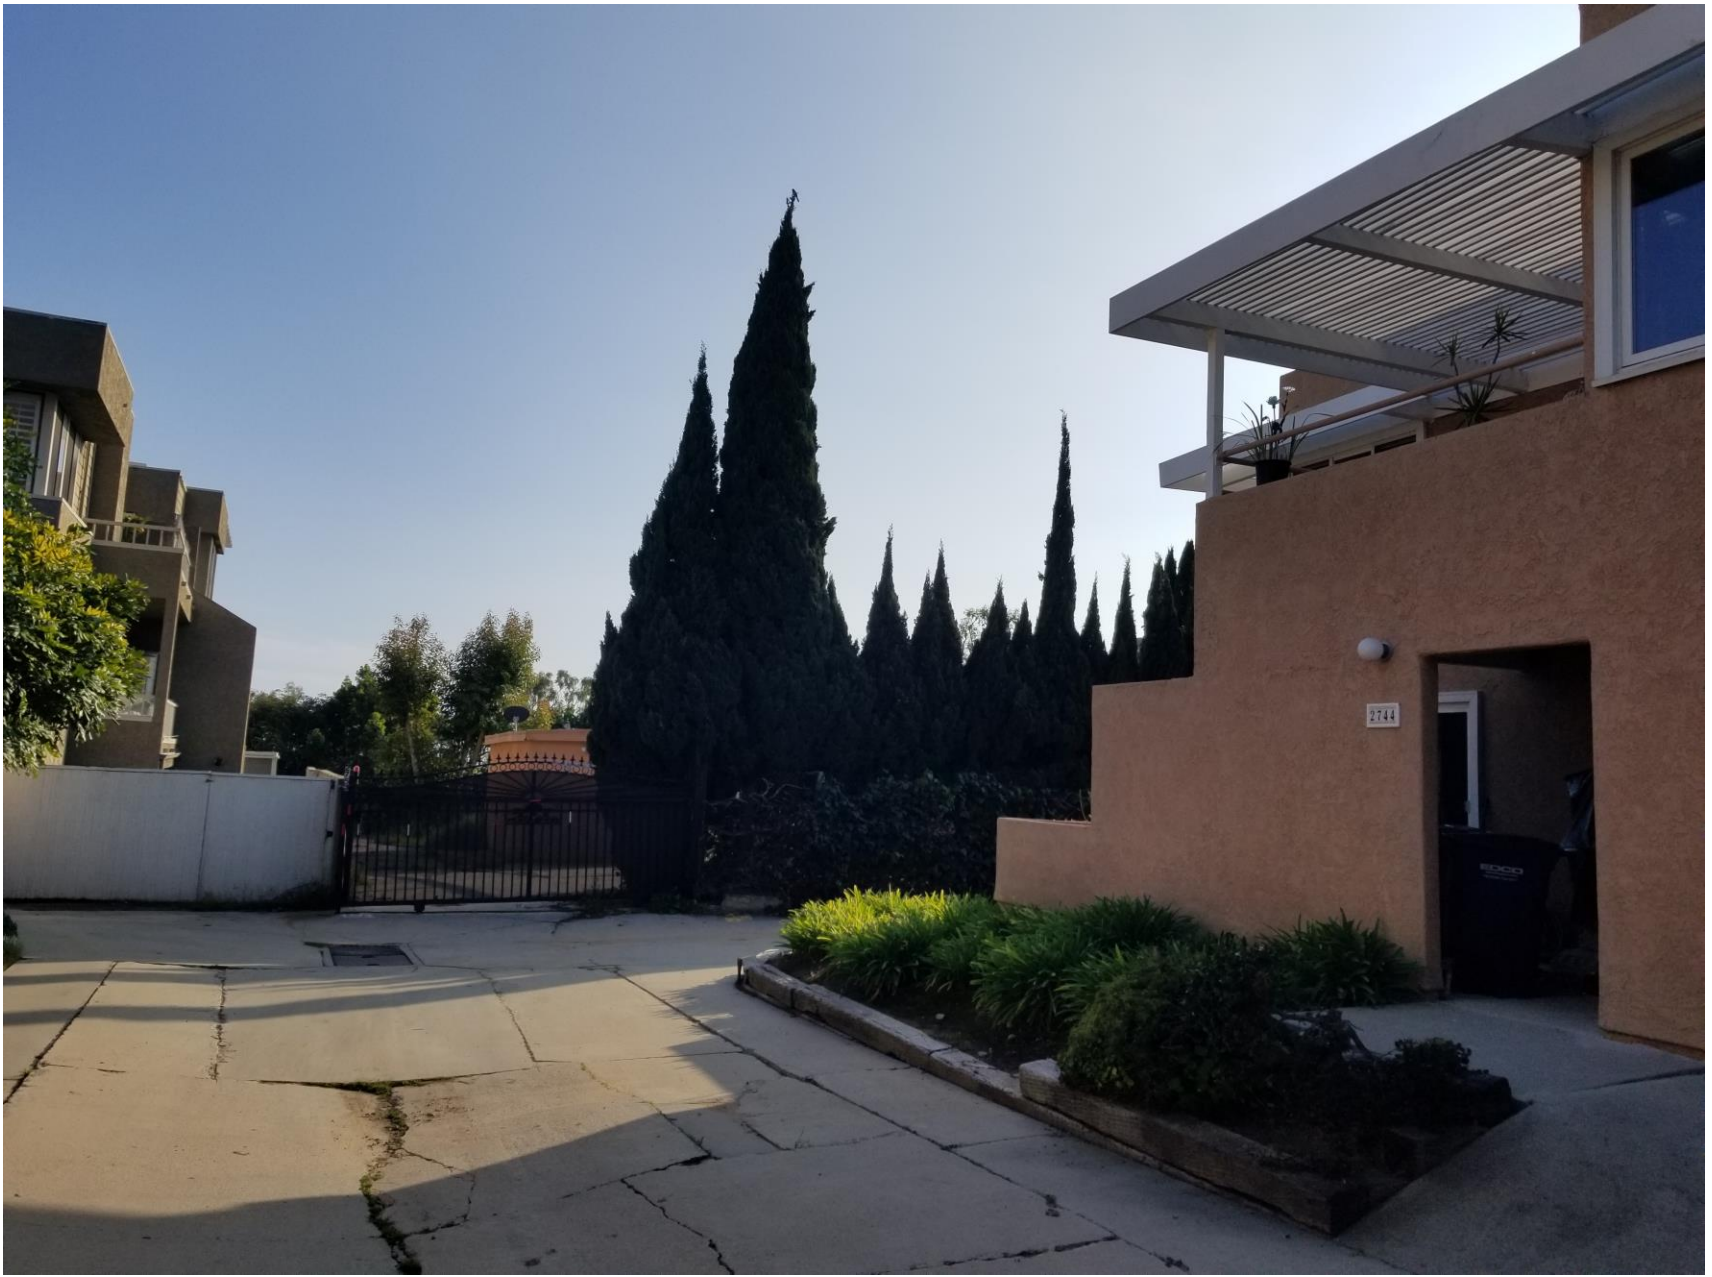
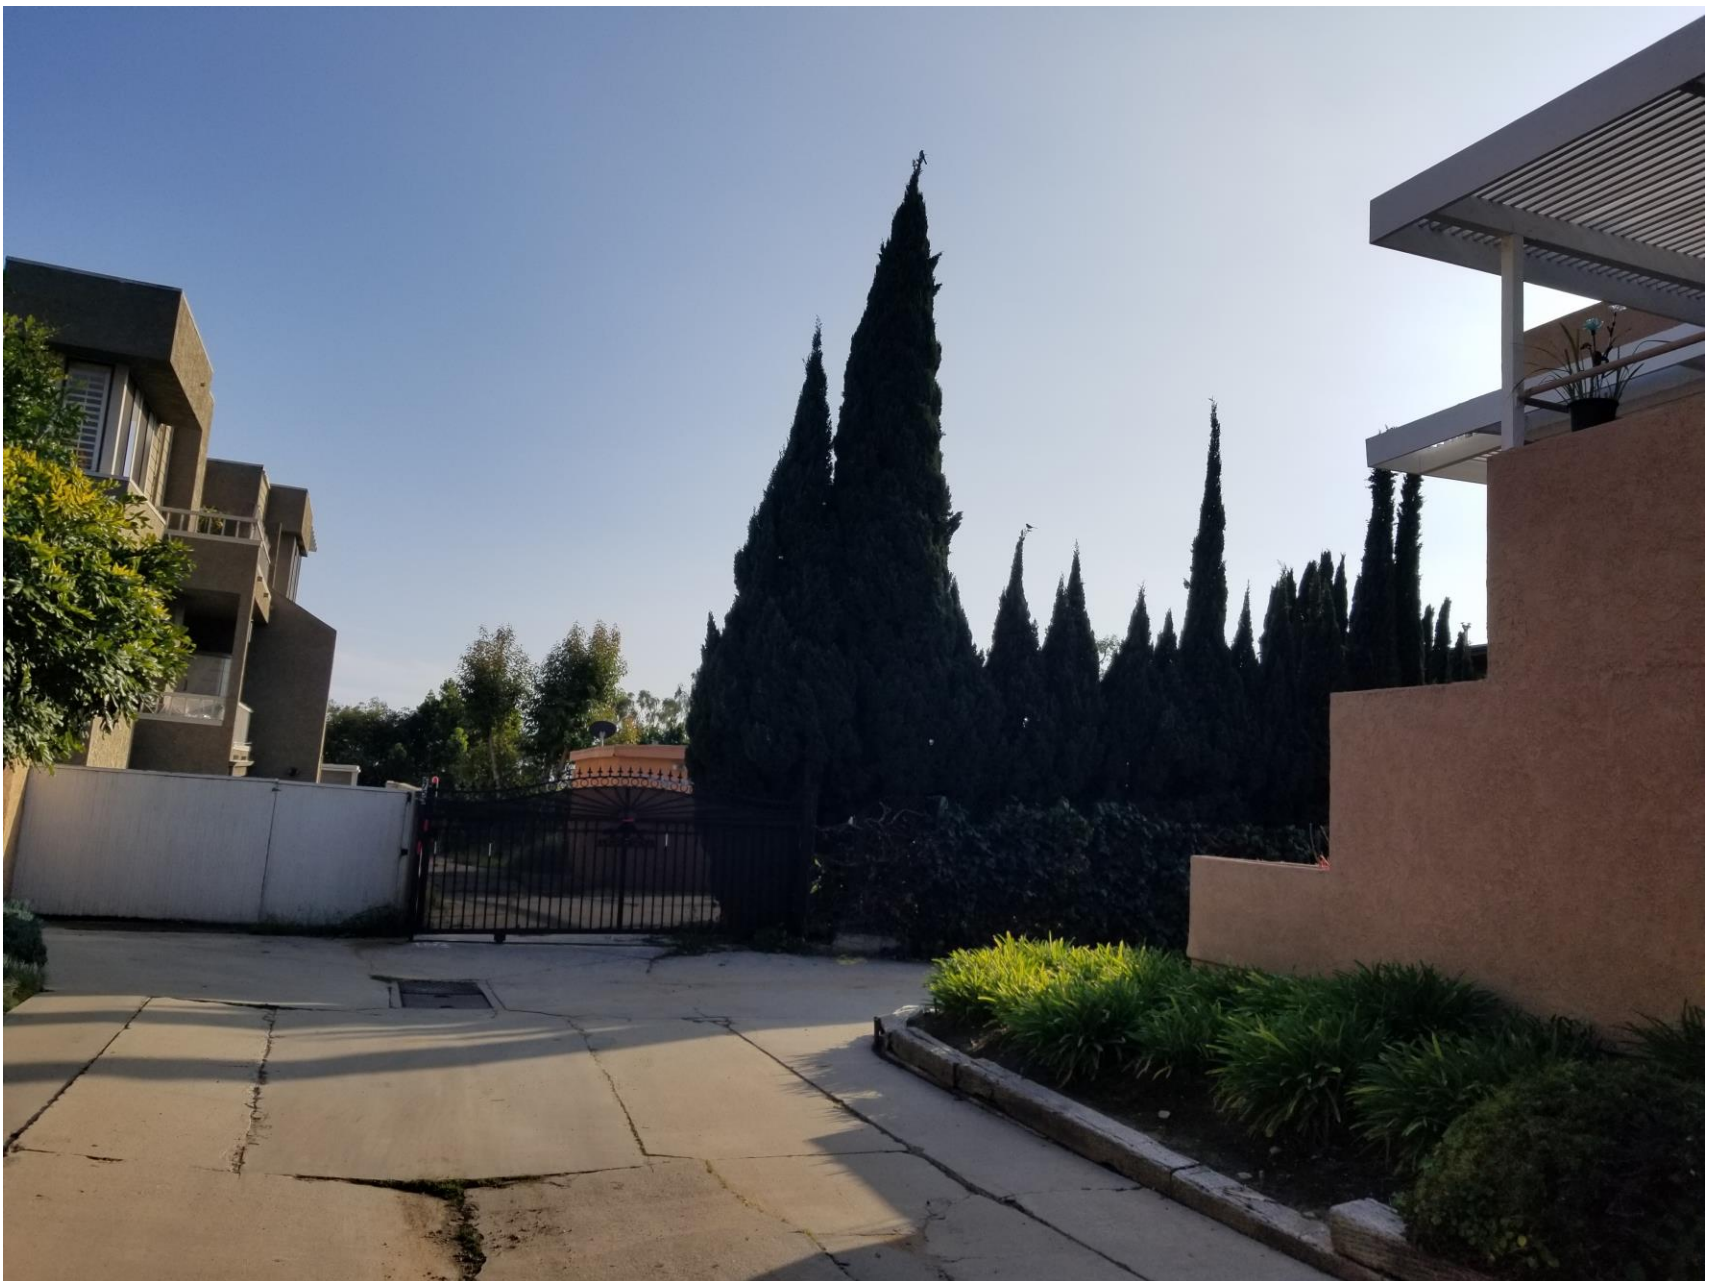
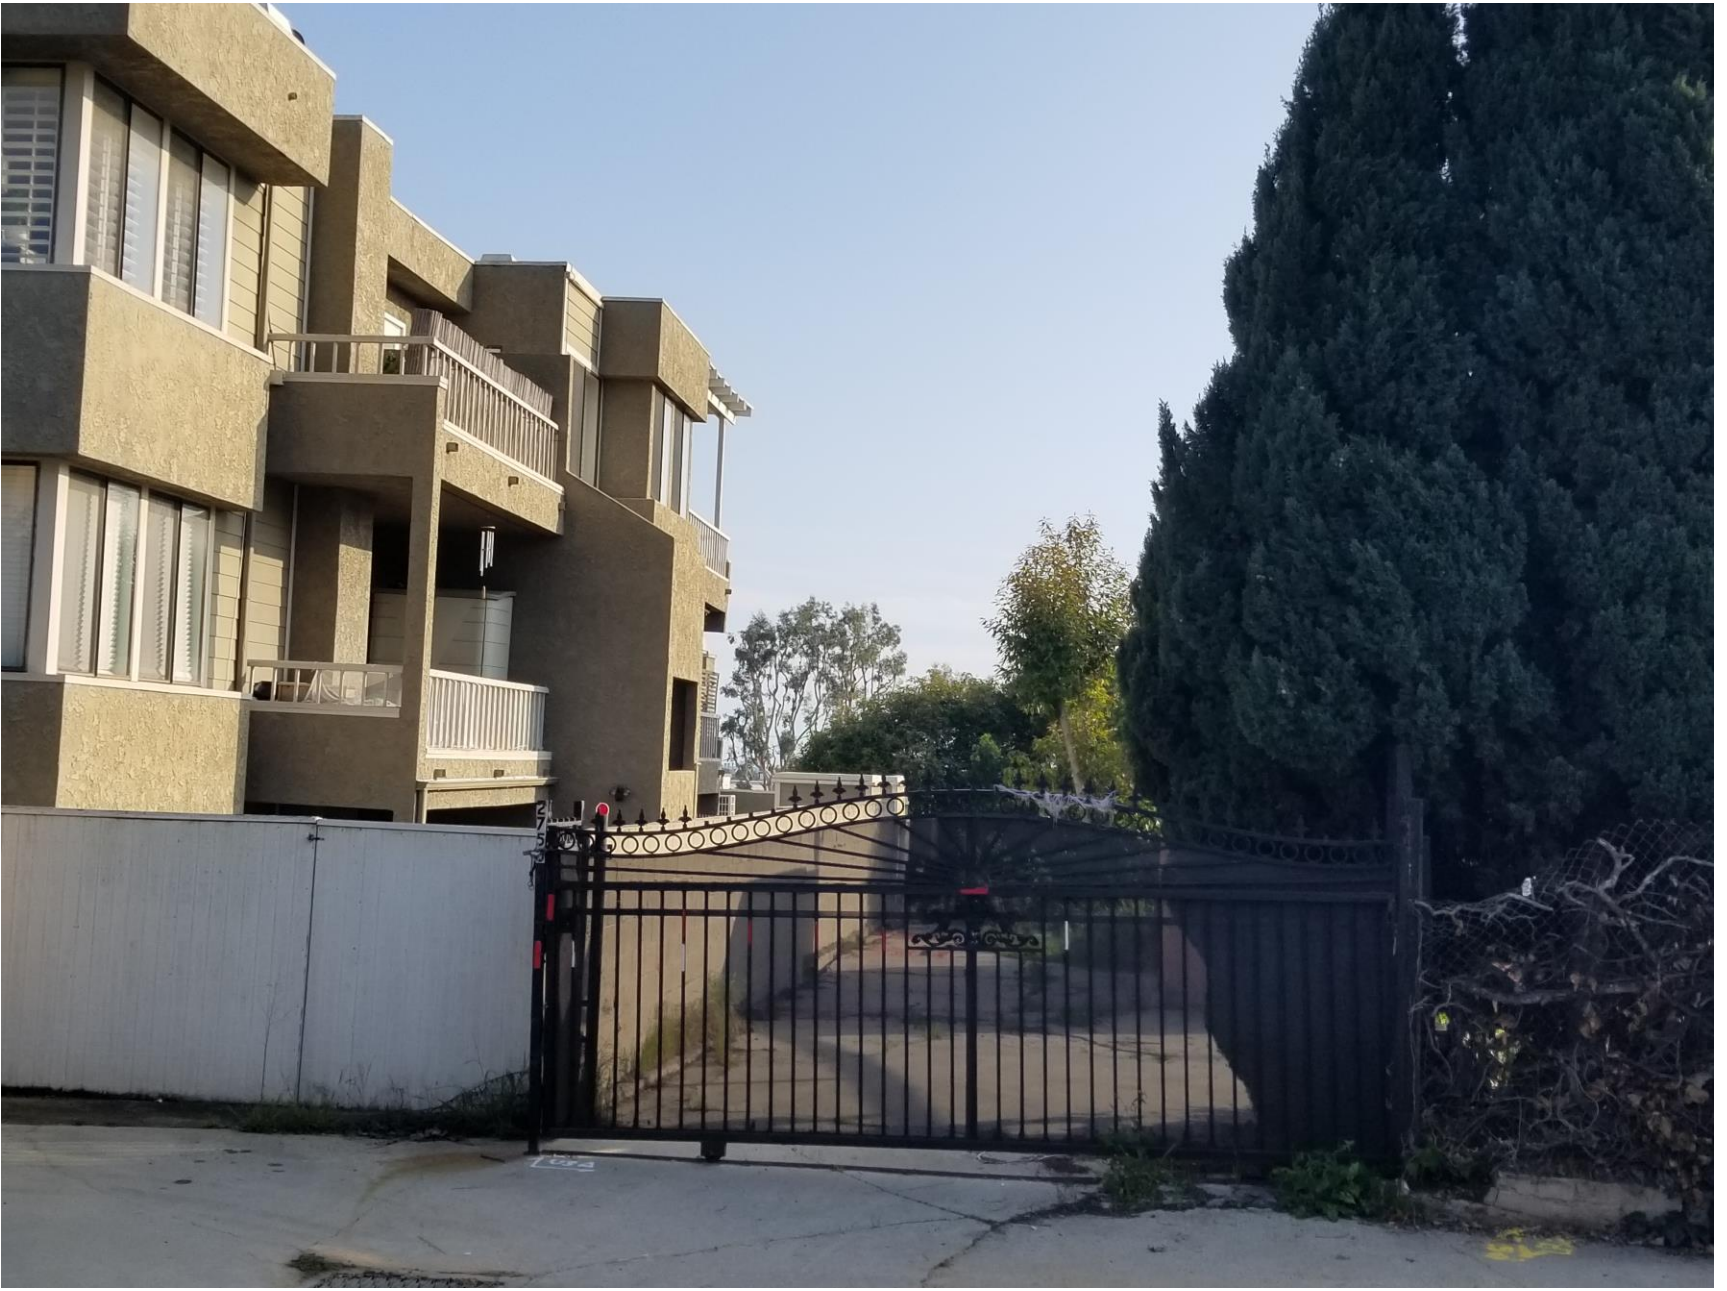
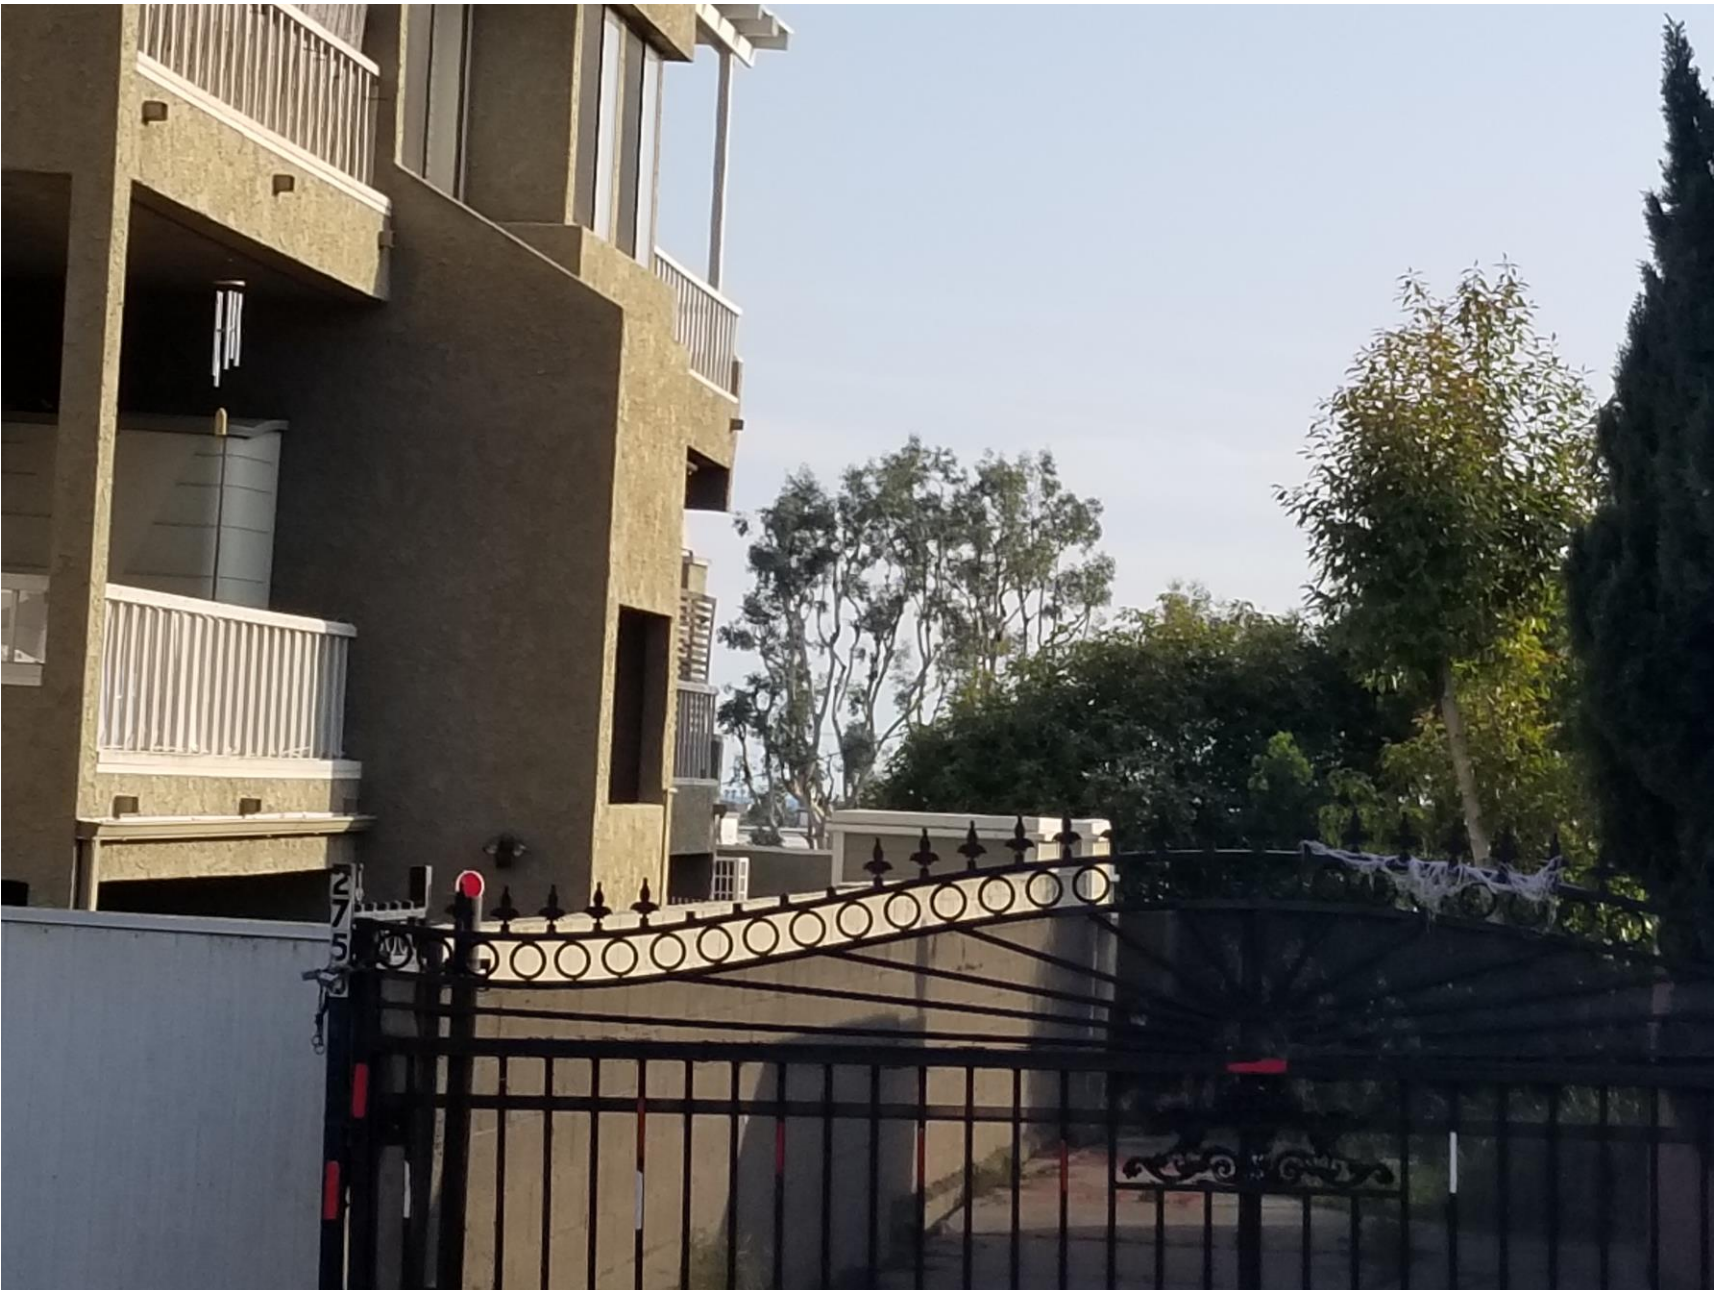
A phone call and message were left for Diana on December 07, 2023, to schedule a view analysis. To date, nobody has responded to the message. Photos were taken from the front and garage side of Diana’s unit at ground level.

<b>View Description</b>	<b>View Policy (Section 3.D)</b>		<b>View Designation</b>
1	Facing South from ground level in front of unit.	Only View in Structure	No	NO IMPACT
		Most Important View	No	
		Subject of View is Unique Landmark	No

As designed, The Courtyard project protects the expansive sky view which is the primary attribute of the unit.
