FACILITY CONDITION ASSESSMENT

FCA and Master Plan Study

City Hall
2175 Cherry Avenue
Signal Hill, CA 90755

October 1, 2024

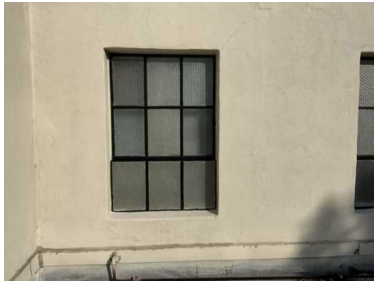
Window in Poor condition.

Steel, 16-25 SF
City Hall
Building Exterior

The exteriors windows are significantly beyond their expected useful life, with observed deteriorated related to age. - AssetCALC ID: 7209726

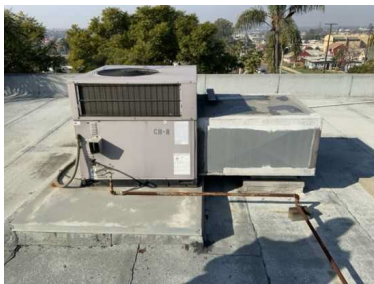
Piping & Valves in Poor condition.

Flexible (Yellow), Natural Gas
City Hall
Main roof

Observed excessive corrosion on gas lines of HVAC equipment on roof. Replace gas lines is recommended. - AssetCALC ID: 7209685

The building is heated and cooled by a series of rooftop packaged units. There is a single split-system heat pump that serves the offices on the lower level. Most of the packaged units were replaced in 2013-14 and will require lifecycle replacements. The heat pump and ductless split system for the data room are aged and will require lifecycle replacement in the near term. The two RTUs on the upper roof have exceeded their lifespan and were observed to be leaking. These units are budgeted for replacement. Excessive corrosion on the gas lines supplying the packaged units was observed. Corrosion will cause pinhole leaks if left unabated. Removing the corrosion or replacing the supply lines are required. A budget cost is included.

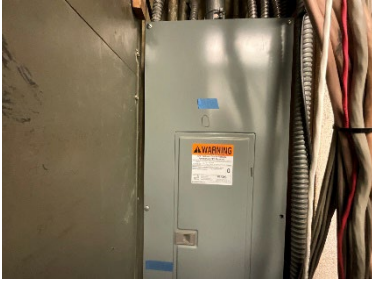
Distribution Panel in Poor condition.

120/240 V, Residential Style, 100 AMP
City Hall
Closet 11 - Closet With Sliding Doors

This panelboard is operational but assumed to be beyond its expected useful life. - AssetCALC ID: 8312718

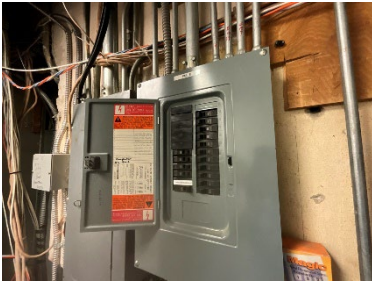
Distribution Panel in Poor condition.

120/240 V, Residential Style, 100 AMP
City Hall
Closet 11 - Closet With Sliding Doors

This panelboard is operational but assumed to be beyond its expected useful life. - AssetCALC ID: 8312636

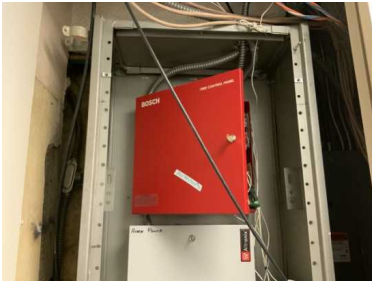
Fire Alarm Panel in Poor condition.

Multiplex
City Hall
Closet 11 - Closet With Sliding Doors

The fire alarm panel has reached the end of its expected useful life and should be replaced soon. - AssetCALC ID: 7209710

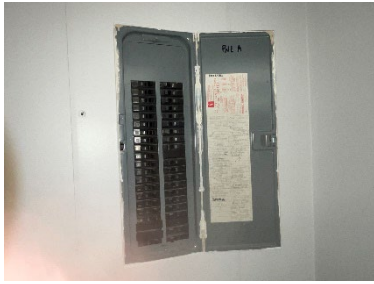
Distribution Panel in Poor condition.

120/240 V, Residential Style, 100 AMP
City Hall
Room 31 - Conference Room

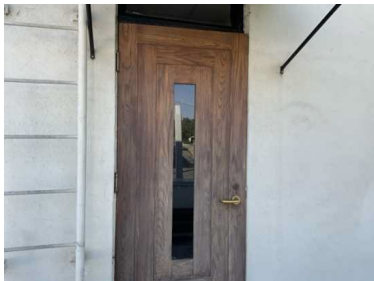
Exterior Door in Poor condition.

Wood, Solid-Core
City Hall
Building Exterior

The door leading from the second-floor conference room onto the roof is weathered. The door requires replacement. - AssetCALC ID: 7209723

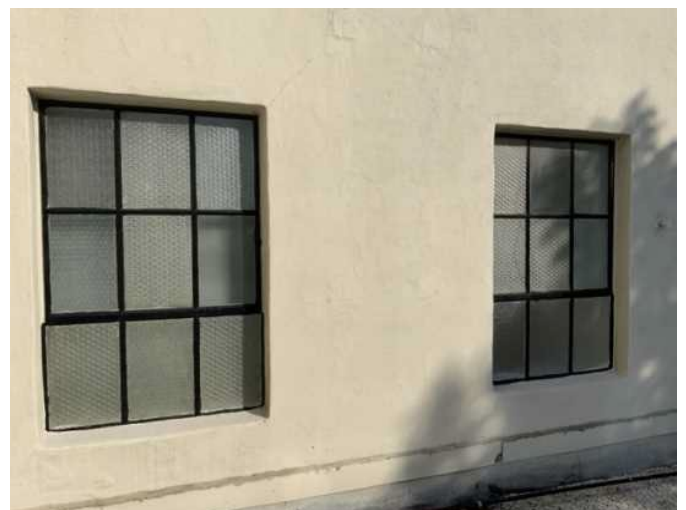
6 - WINDOWS

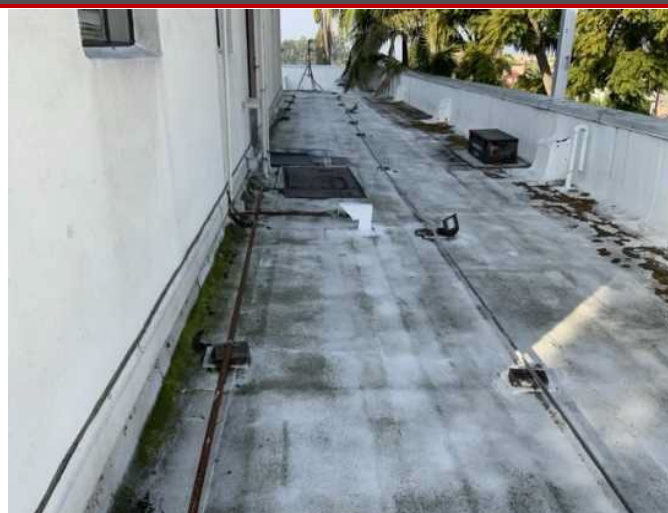
8 - PRIMARY ROOF OVERVIEW

The masonry building was built into a hill and has a basement and a partial upper level in addition to the main floor. The flat roofs are finished with modified bitumen membranes that are approximately 13 years old. There is an area of ponding on the west side corner of the main roof. The roof in this area requires re-sloping and the drain should be enlarged. A cost for roof repairs is included in the immediate needs budget. An exterior wood door leading from the second-floor conference room onto the roof is aged and weathered. The door is recommended for replacement. The windows appear to be original single-paned steel units. The wood-framed, fully glazed entry doors are aged and ill-fitting. The doors and windows are budgeted for replacement. The exterior walls are finished with stucco that exhibits weathering and stains. Stucco fog and painting are budgeted in the near term.

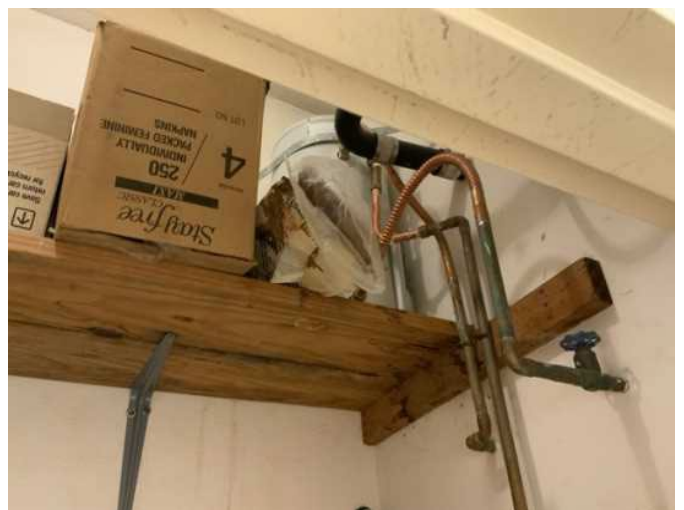
18 - WATER HEATER

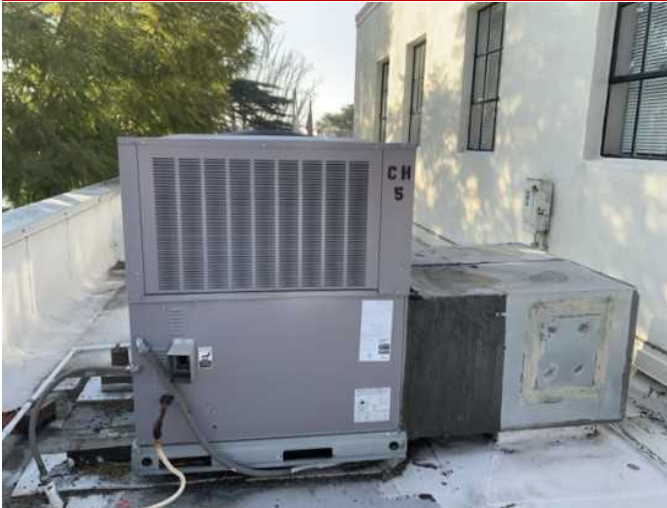
19 - ROOFTOP MECHANICAL EQUIPMENT

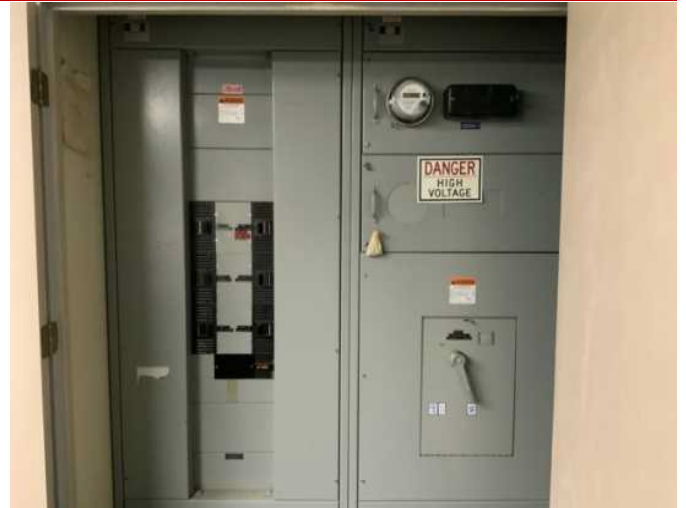
20 - MAIN ELECTRICAL ROOM

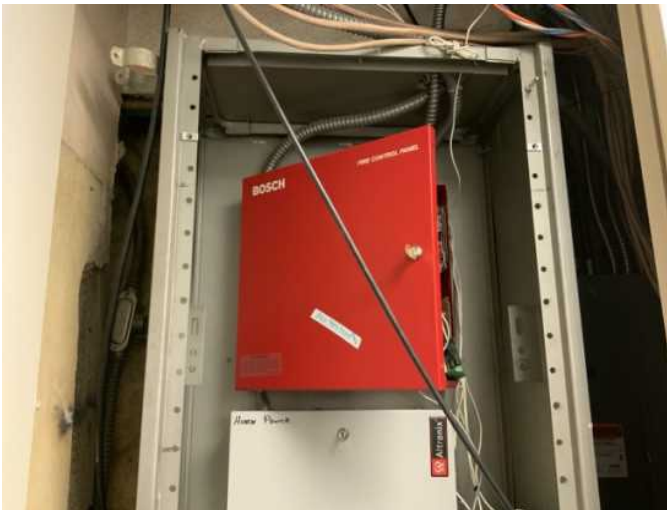
21 - FIRE ALARM PANEL

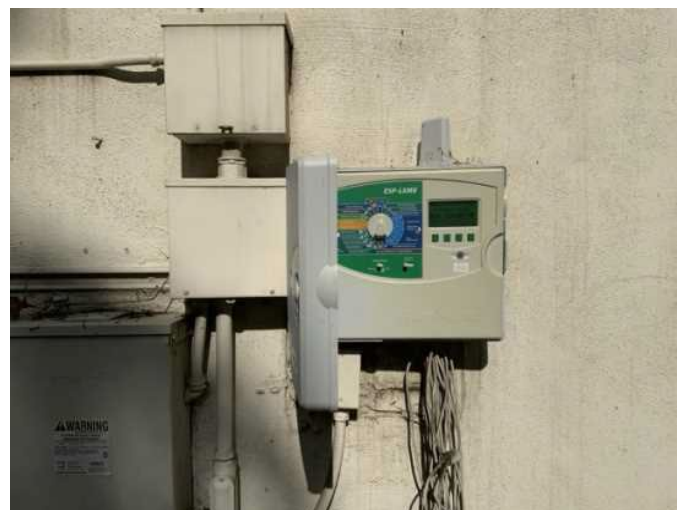
24 - IRRIGATION SYSTEM

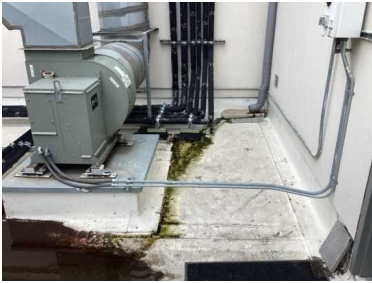
Roofing in Poor condition.

any type, Repairs per Man-Day
Signal Hill Library
Secondary Roof

Water ponding observed. Adjust slope for proper drainage. - AssetCALC ID: 7218564

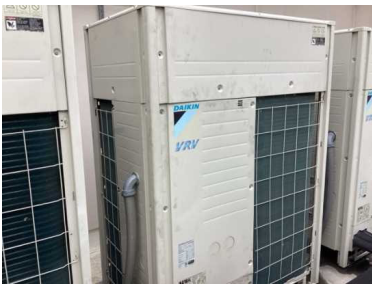
Heat Pump in Failed condition.

Var Refrig Vol (VRV)
Signal Hill Library
Secondary Roof

Not functional. - AssetCALC ID: 7218616

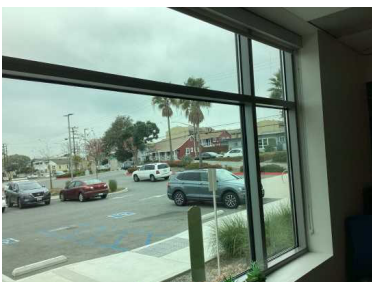
Caulking in Poor condition.

Window Edge/Trim, per 12 SF Window (or 14 LF)
Signal Hill Library
Offices

Water leakage at windows during rain season. Window repairs are required. - AssetCALC ID: 7218586

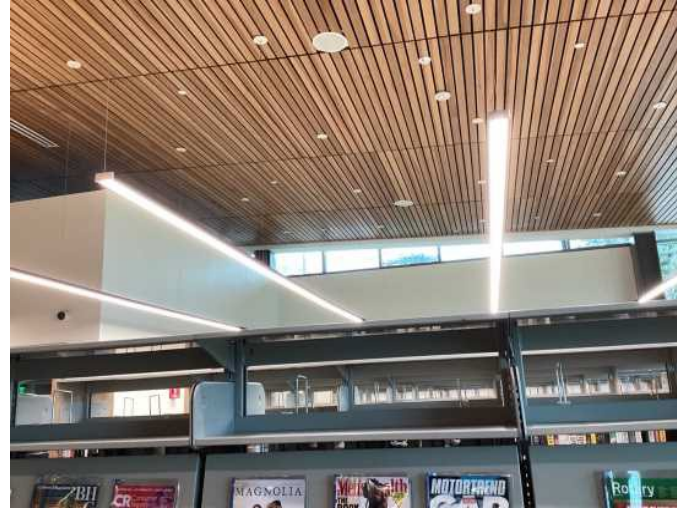
20 - INTERIOR LIGHTING SYSTEM

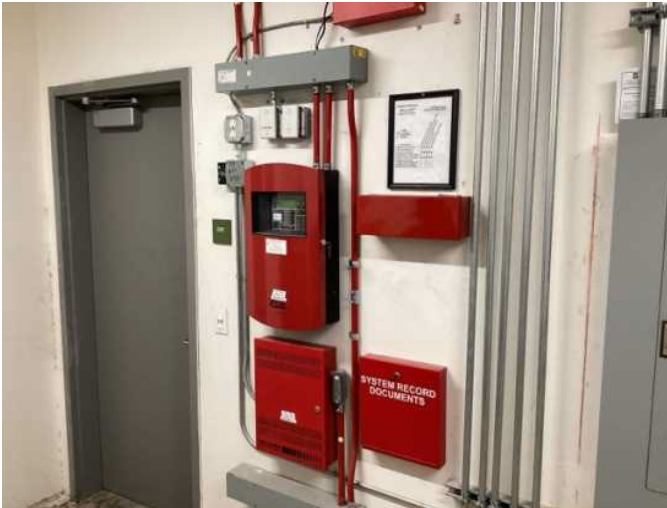
21 - FIRE ALARM PANEL

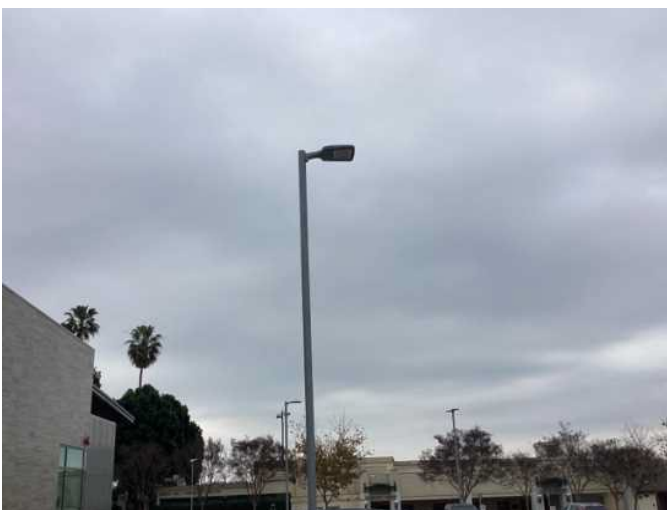
23 - SITE LIGHT POLE

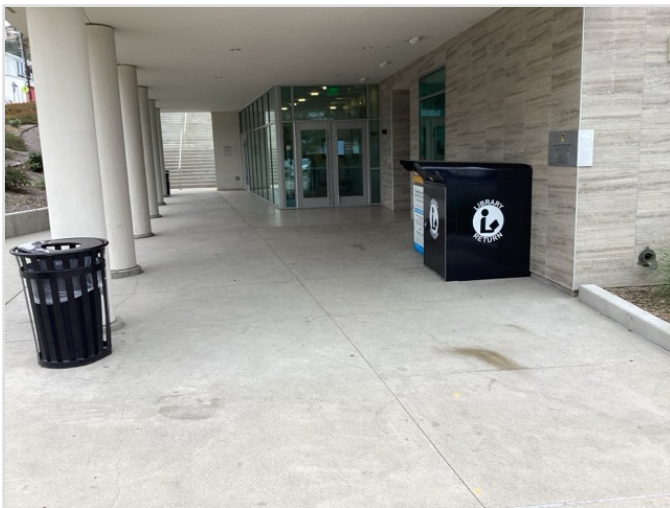
ACCESSIBLE PATH

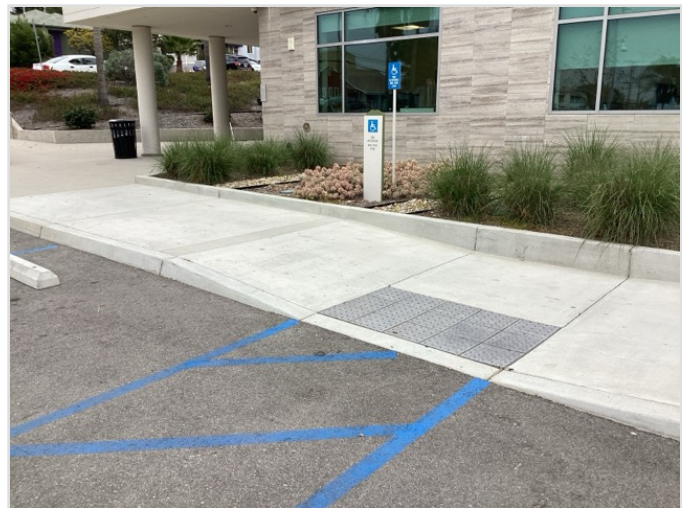
CURB CUT

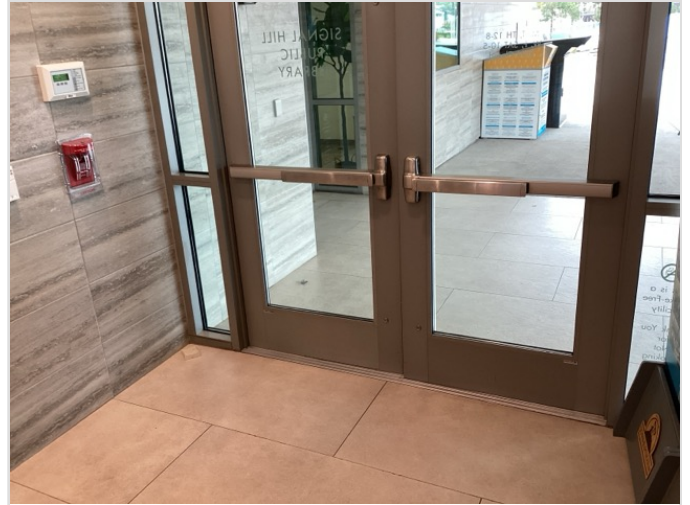
DOOR HARDWARE

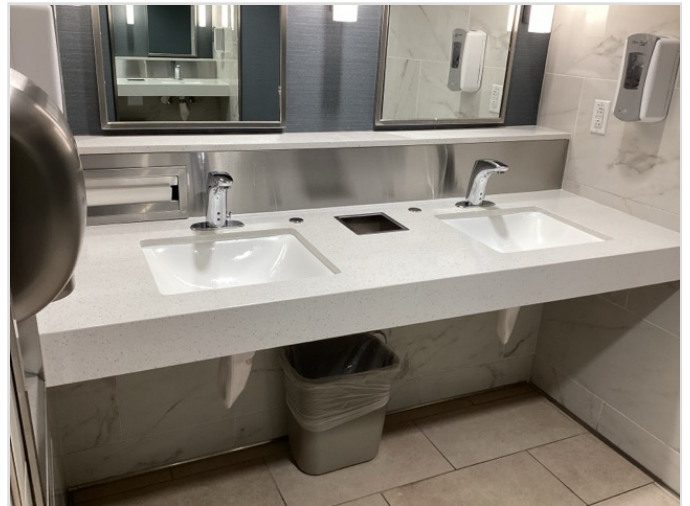
SINK, FAUCET HANDLES AND ACCESSORIES

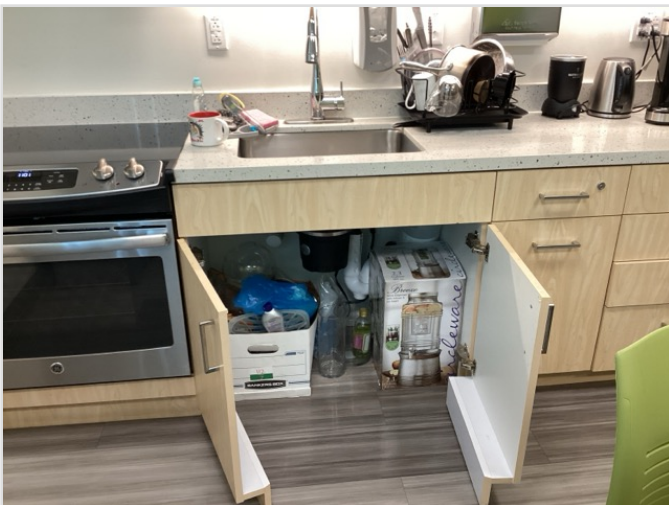
SINK CLEARANCE

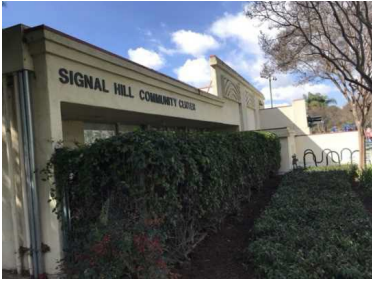
Exterior Walls in Poor condition.

Stucco
Youth Center
Building Exterior

The foam detailing is damaged and difficult to repair. - AssetCALC ID: 7418316

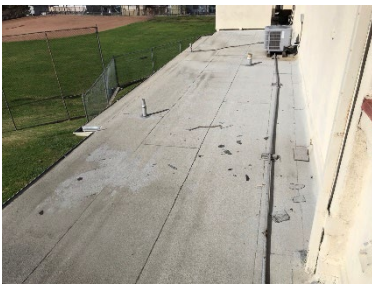
Roofing in Poor condition.

Modified Bitumen
Youth Center
Roof

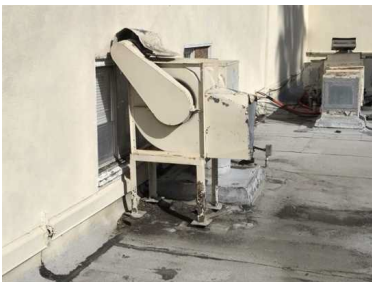
Exhaust Fan in Poor condition.

Centrifugal, 36" Damper
Youth Center
Roof

The unit is corroded and not fully operational. - AssetCALC ID: 7418326

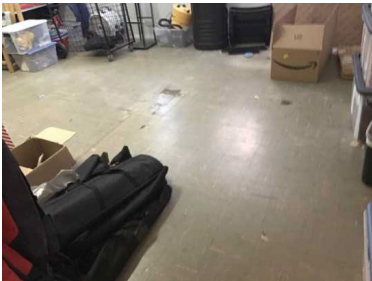
Flooring in Poor condition.

Vinyl Tile (VCT), Residential In-House
Installation
Youth Center
Upstairs office

The flooring has missing and deteriorated tiles. - AssetCALC ID: 7418340

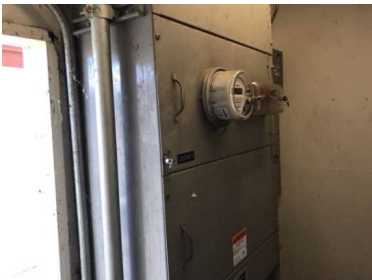
Distribution Panel in Poor condition.

120/208 V
Youth Center
Electrical room

This panel is likely original construction and beyond its expected useful life. - AssetCALC ID: 7418298

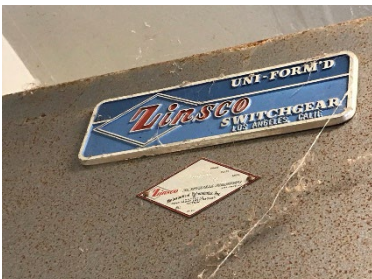
Distribution Panel in Poor condition.

120/208 V
Youth Center
Electrical room

This panel is likely original construction and many years beyond its expected useful life. Zinsco electrical equipment is no longer manufactured and has a history of safety issues (<https://www.usinspect.com/blog/what-zinsco-panel-and-why-should-i-care/>). - AssetCALC ID: 7418333

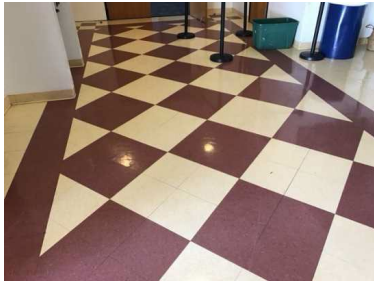
**Flooring in Poor condition.**

Vinyl Tile (VCT)
Youth Center
Throughout building

The flooring has cracks and popping as it's walked on. - AssetCALC ID: 7418337

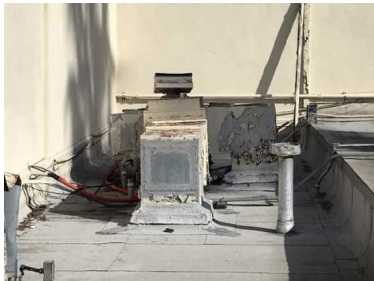
**Make-Up Air Unit in Poor condition.**

MUA or MAU
Youth Center
Roof

The unit is moderately corroded and not fully operational. - AssetCALC ID: 7418311

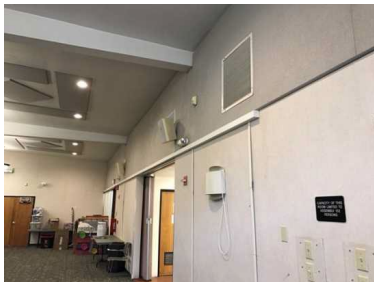
**HVAC System in Poor condition.**

Ductwork, Medium Density
Youth Center
Throughout building

The ductwork is leaking at multiple locations throughout the facility, with condensation likely being the issue. - AssetCALC ID: 7418354

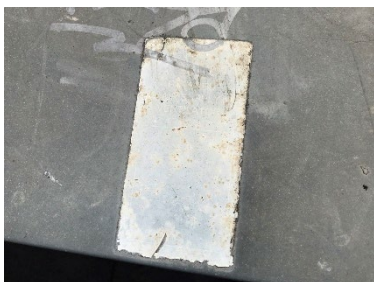
**Evaporative Cooler in Poor condition.**

0.75 to 1 HP
Youth Center
Roof

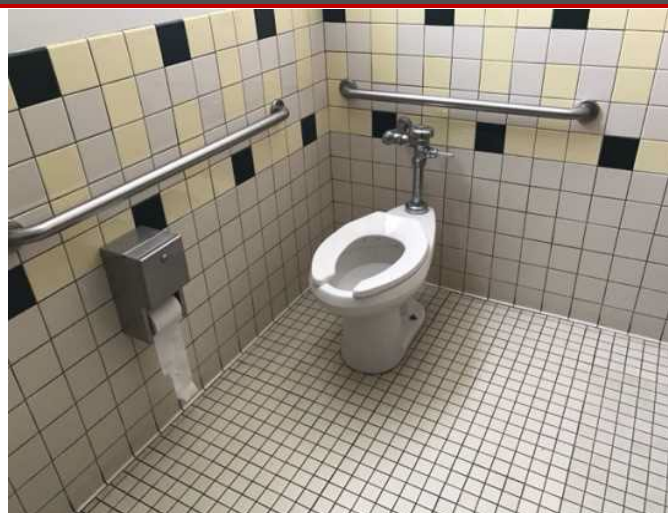
14 - TOILET STALL OVERVIEW

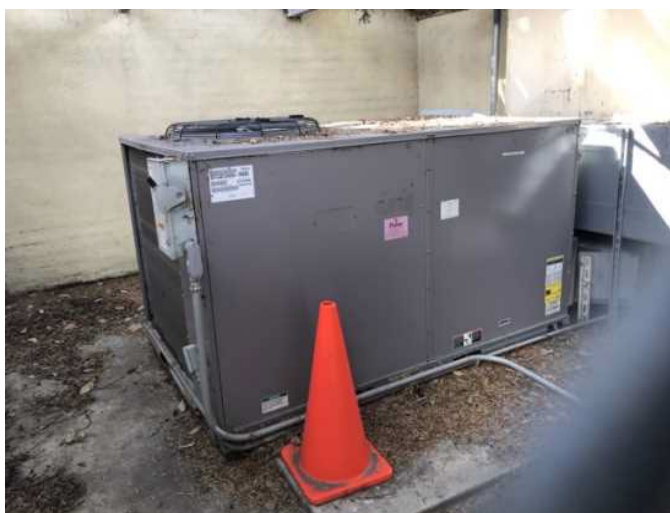
15 - PACKAGED UNIT

D3050	Roof	Poor	Make-Up Air Unit, MUA or MAU	1	0	7418311
D3050	Site	Fair	Packaged Unit, RTU, Pad or Roof-Mounted	1	10	7418285
D3050	Roof	Fair	Packaged Unit, RTU, Pad or Roof-Mounted	1	3	7418331
D3060	Roof	Fair	Exhaust Fan, Centrifugal, 28" Damper	1	3	7418349
D3060	Building exterior	Fair	Exhaust Fan, Roof or Wall-Mounted, 10" Damper	1	3	7418290
D3060	Roof	Fair	Exhaust Fan, Centrifugal, 42" Damper	1	3	7418300
D3060	Building exterior	Fair	Exhaust Fan, Roof or Wall-Mounted, 16" Damper	1	7	7418313
D3060	Roof	Poor	Exhaust Fan, Centrifugal, 36"Damper	1	0	7418326
Electrical						
D5020	Electrical room	Poor	Distribution Panel, 120/208 V	1	0	7418333
D5020	Electrical room	Poor	Distribution Panel, 120/208 V	1	0	7418298
D5030	Throughout building	Fair	Electrical System, Wiring & Switches, Average or Low Density/Complexity	10,864 SF	5	7418332
D5040	Building exterior	Fair	Exterior Fixture w/ Lamp, any type, w/ LED Replacement	12	6	7418305

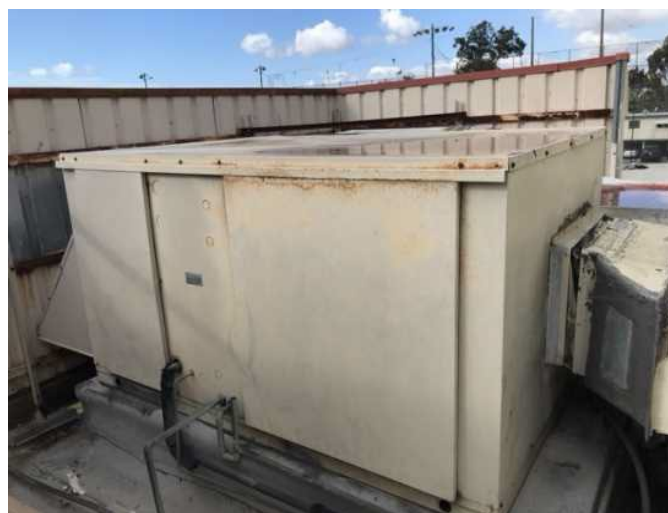
16 - PACKAGED UNIT

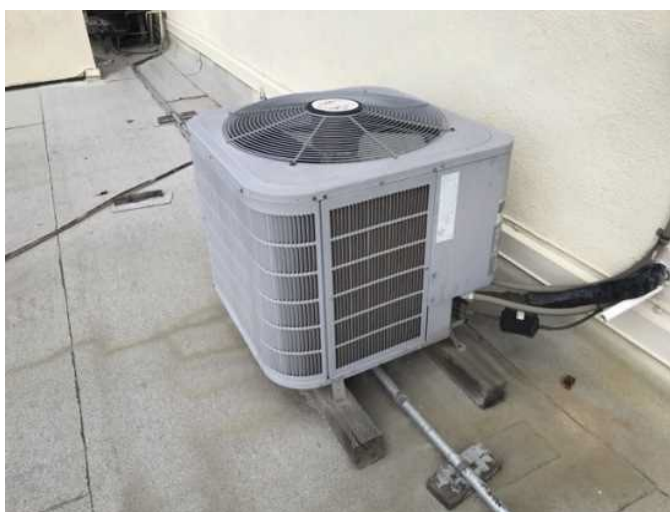
17 - SPLIT SYSTEM

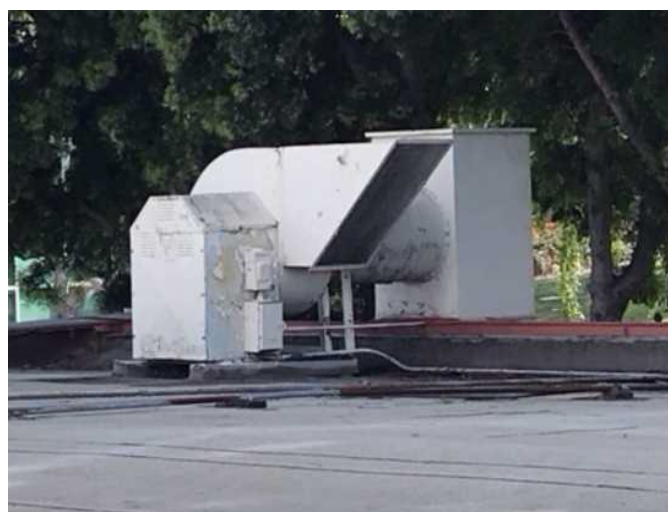
18 - EXHAUST FAN

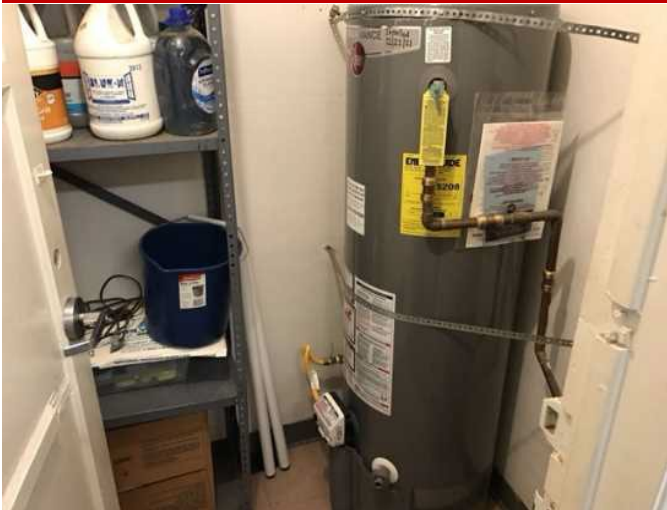
19 - WATER HEATER

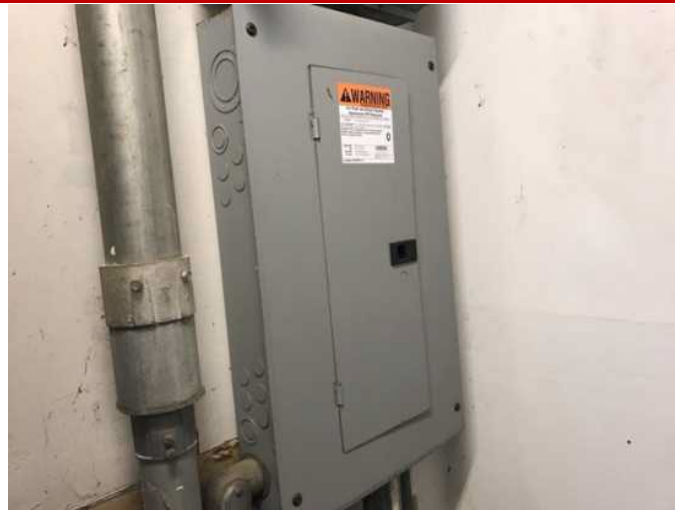
20 - DISTRIBUTION PANEL

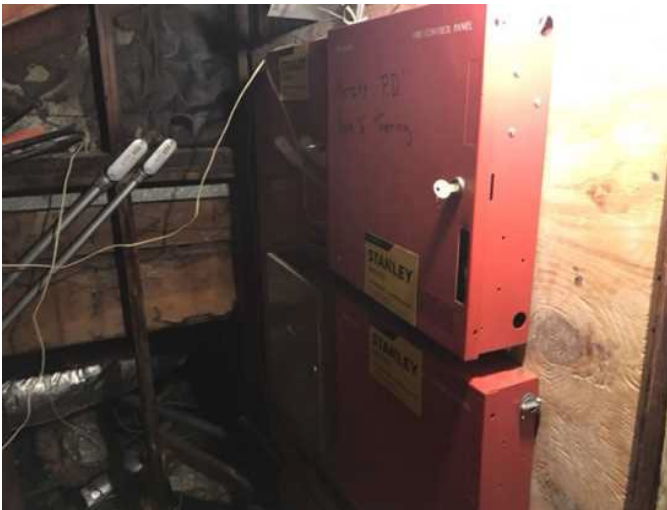
21 - FIRE ALARM PANEL

D5040	7418312	Exterior Fixture w/ Lamp, any type, w/ LED Replacement, Replace	20	10	10	5	EA	\$960.00	\$4,800											\$4,800											\$4,800
D7050	7418330	Fire Alarm Panel, Fully Addressable, Replace	15	8	7	1	EA	\$24,000.00	\$24,000								\$24,000														\$24,000
D7050	7418319	Fire Alarm System, Full System Upgrade, Standard Addressable, Upgrade/Install	20	10	10	10864	SF	\$4.80	\$52,147											\$52,147											\$52,147
E1030	7418299	Foodservice Equipment, Range/Oven, 6-Burner w/ Griddle, Replace	15	8	7	1	EA	\$16,320.00	\$16,320								\$16,320														\$16,320
E1030	7418343	Foodservice Equipment, Exhaust Hood, 3 to 6 LF, Replace	15	8	7	1	EA	\$5,280.00	\$5,280								\$5,280														\$5,280
E1030	7418335	Foodservice Equipment, Refrigerator, 2-Door Reach-In, Replace	15	6	9	1	EA	\$7,360.00	\$7,360										\$7,360												\$7,360
E1030	7418351	Foodservice Equipment, Freezer, 2-Door Reach-In, Replace	15	5	10	1	EA	\$8,160.00	\$8,160											\$8,160											\$8,160

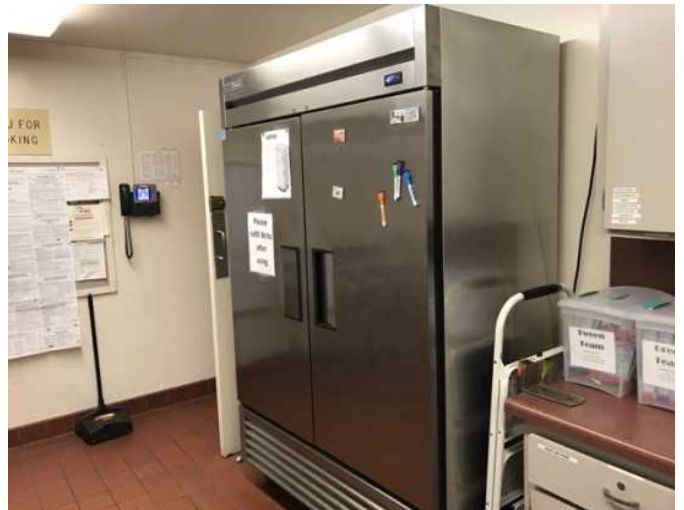
22 - FOODSERVICE EQUIPMENT

3	7418299	E1030	Foodservice Equipment	Range/Oven, 6-Burner w/ Griddle		Youth Center	Commercial kitchen	Montague	Inaccessible	Inaccessible			1
4	7418335	E1030	Foodservice Equipment	Refrigerator, 2-Door Reach-In		Youth Center	Commercial kitchen	True Manufacturing Co	T-49-HC	9201764	2018		1

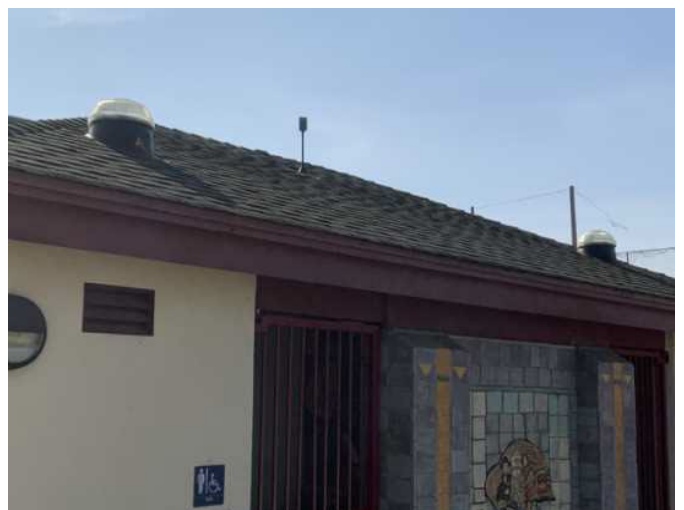
6 - PRIMARY ROOF OVERVIEW

The masonry building was constructed on a concrete slab. The gabled roof is finished with asphalt shingles. The roof will require only lifecycle replacement. The building has no windows and the entry doors are heavy metal gates. The interior floors are finished with an epoxy coating and the walls are painted CMU. The ceilings have a spray finish. The interior and exterior finishes will require only lifecycle replacement.

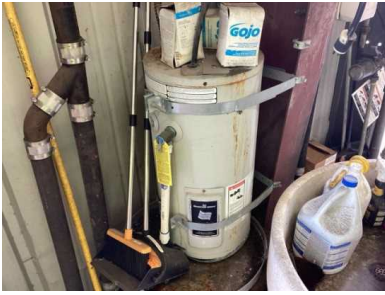
**Water Heater in Failed condition.**

Electric, Commercial (12 kW)
Building Maintenance & Fleet Division City Yard
Fleet Shop Building Northeast

Nonfunctional. - AssetCALC ID: 7336573

The electric water heater is nonfunctional and replacement cost has been added immediate budget.

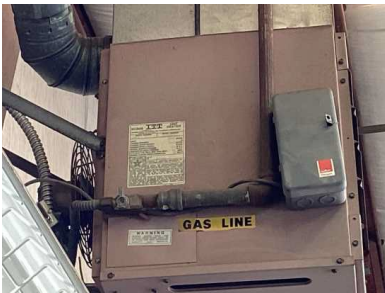
**Unit Heater in Poor condition.**

Natural Gas
Building Maintenance & Fleet Division City Yard
Throughout Building

This unit heater is not functioning because gas lines are shut off. - AssetCALC ID: 7336658

The unit heaters are old and in poor condition, rendered non-functional due to a lack of gas supply in the building. Therefore, a utility study is recommended to thoroughly assess the issues and determine the cost associated with repairs. Heaters are recommended to be replaced in near future. Small window AC units serving office space were in fair condition and do not need any immediate replacement.

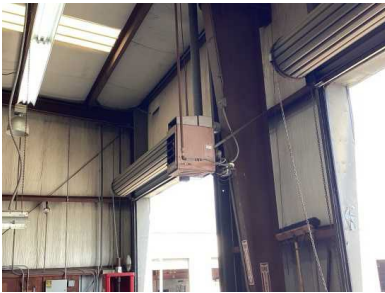
**Unit Heater in Poor condition.**

Natural Gas
Building Maintenance & Fleet Division City Yard
Throughout Building

This unit heater is not functioning because gas lines are shut off. - AssetCALC ID: 7336644

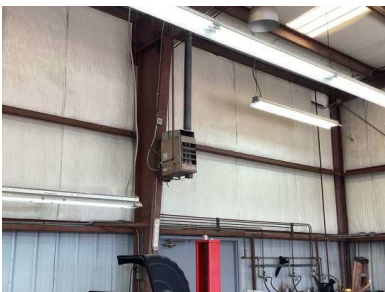
**Unit Heater in Poor condition.**

Natural Gas
Building Maintenance & Fleet Division City Yard
Throughout Building

This unit heater is not functioning because gas lines are shut off. - AssetCALC ID: 7336656

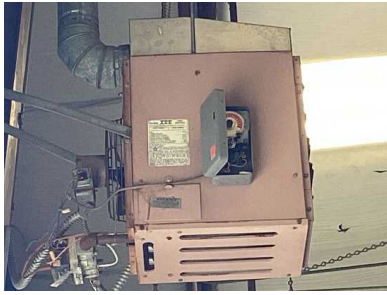
Unit Heater in Poor condition.

Natural Gas
Building Maintenance & Fleet Division City Yard
Throughout Building

This unit heater is not functioning because gas lines are shut off. - AssetCALC ID: 7336687

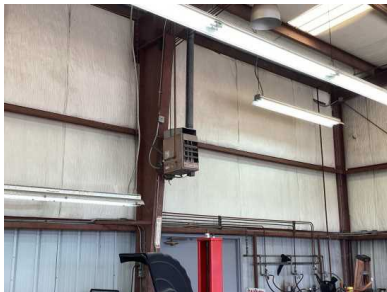
Unit Heater in Poor condition.

Natural Gas
Building Maintenance & Fleet Division City Yard
Throughout Building

This unit heater is not functioning because gas lines are shut off. - AssetCALC ID: 7336670

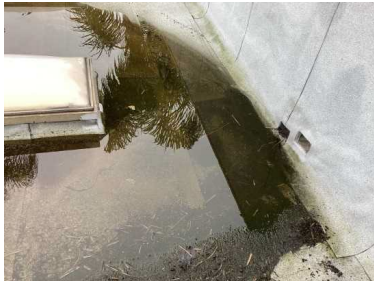
Roofing in Failed condition.

any type, Repairs per Man-Day
City Yard Offices
Roof

Water ponding was observed at the drain slope side of the roof, and water leakage is an issue as drainage slope needs to be fixed. This repair effort can be conducted prior to replacing the roof and skylights if funding for the larger effort may not be immediately available. If the funds to replace the roof and skylights are available soon, I would wait for the major project to address this situation. - AssetCALC ID: 7336586

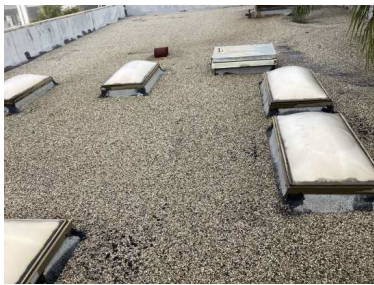
Roofing in Poor condition.

Built-Up
City Yard Offices
Roof

This roof covering is well beyond its expected useful life and should be renewed soon. Water ponding was observed at the drain slope side of the roof, and water leakage is an issue as drainage slope needs to be fixed. The skylights are also beyond their expected useful life and should be renewed as part of this project. - AssetCALC ID: 7336637

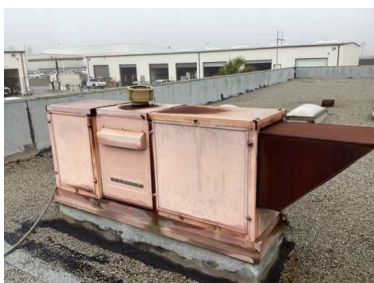
Furnace in Failed condition.

Gas
City Yard Offices
Roof

This unit is not operational. - AssetCALC ID: 7336597

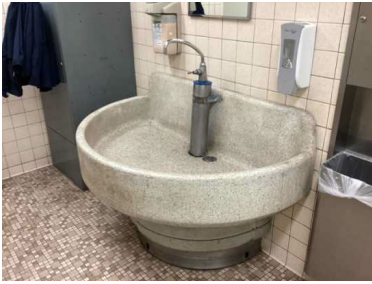
Sink/Lavatory in Poor condition.

Multi-user Sink, Floor
City Yard Offices
City Yard Offices - Restrooms

This is a retrofitted original sink, with hot water not working. - AssetCALC ID: 7336667

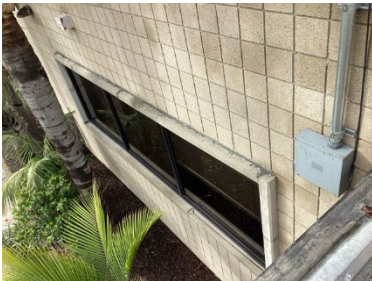
Recommended Follow-up Study:

Building Envelope, Façade, Roof
City Yard Offices
City Yard Offices - Exterior Windows and Roof

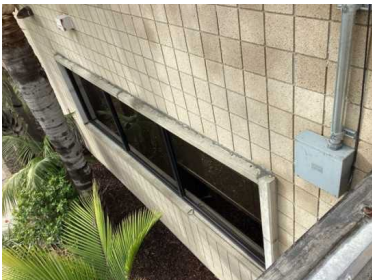
Flashing in Failed condition.

Window Edge/Trim, per 24 SF Window (or 20 LF)
City Yard Offices
Exterior

Window leakages observed. Provide flashing and positive slope away from the building. - AssetCALC ID: 7336633

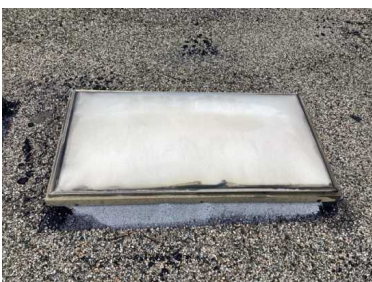
Roof Skylight in Poor condition.

per unit, up to 20 SF
City Yard Offices
Roof

These skylights are well beyond their expected useful life and should be renewed soon. This work should be included with the recommendation to replace the roof. - AssetCALC ID: 7336659

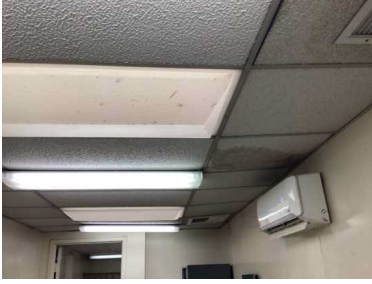
Suspended Ceilings in Poor condition.

Acoustical Tile (ACT)
City Yard Offices
Men's Restroom

A slight sway or deflection in suspended ceiling was observed at this location. Replace damaged acoustic ceiling tiles, suspended ceiling hanger wire, and struts. - AssetCALC ID: 7336608

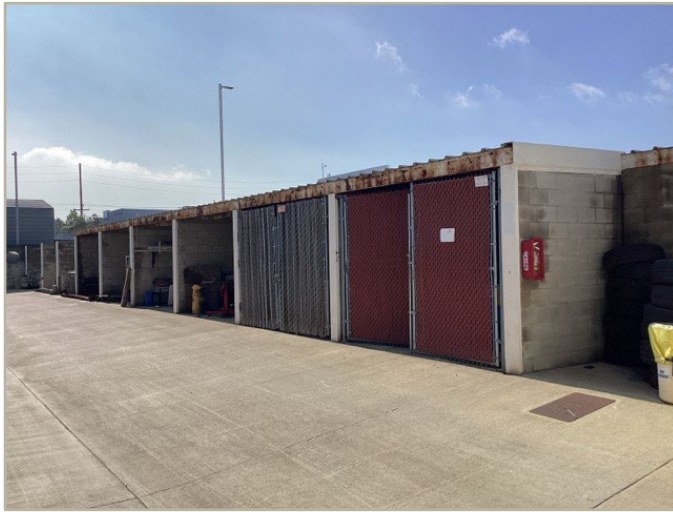
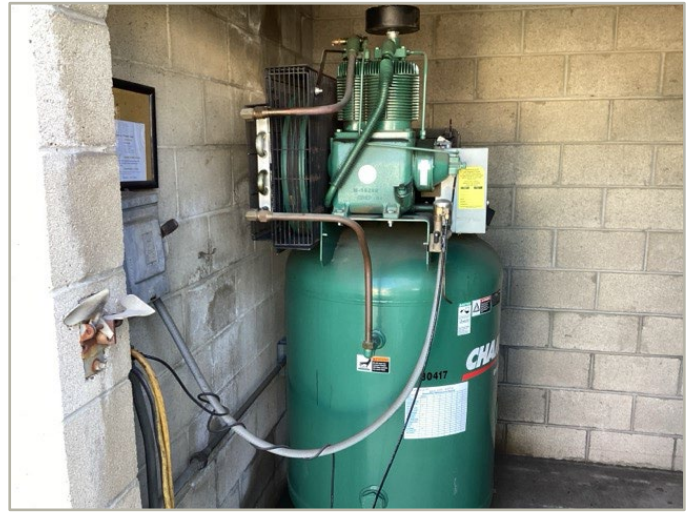
4. Material Storage Bins

Address	2175 East 28th Street, Signal Hill, CA 90755	
Constructed/Renovated	1985	
Building Area	1,253 SF	
Number of Stories	1 above grade	
<i>System</i>	<i>Description</i>	<i>Condition</i>
Structure	Concrete block wall with metal roof deck supported by concrete slab	Fair
Facade	Wall Finish: CMU Windows: None	Fair
Roof	Flat construction with metal finish	Fair
Interiors	Walls: Unfinished Floors: unfinished concrete Ceilings: Unfinished/exposed	Fair
Elevators	None	-
Plumbing	None	-

The structure is supported by concrete block walls, all resting on a concrete slab. Notably, the exposed metal roof structure exhibits signs of rust, necessitating immediate repairs, the costs of which are included in the budget for immediate needs.

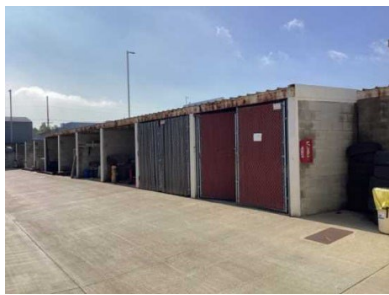
Roof Structure in Poor condition.

Flat, Metal Deck Over Bar Joists
Material Storage Bins City Yard Roof Structure

The metal structure is moderately corroded. - AssetCALC ID: 7340463

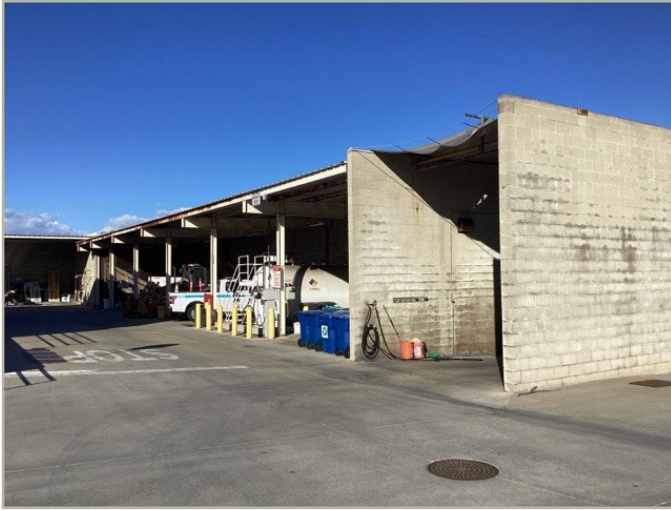
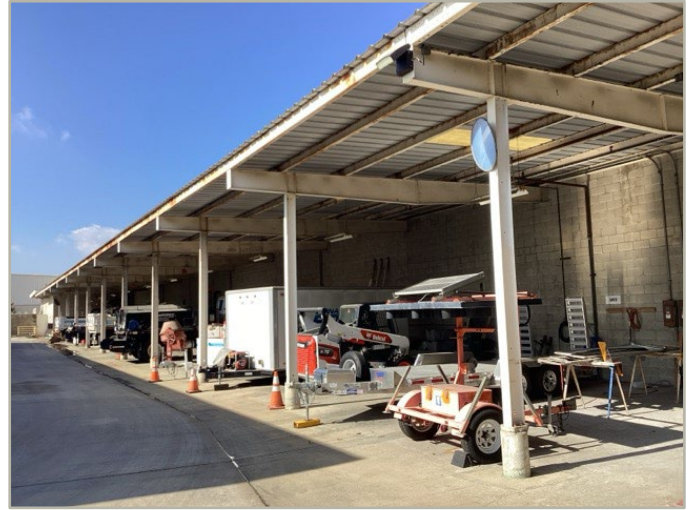
5. Shade Structure A

Address	2175 East 28th Street, Signal Hill, CA 90755	
Constructed/Renovated	1985	
Building Area	10,576 SF	
Number of Stories	1 above grade	
<i>System</i>	<i>Description</i>	<i>Condition</i>
Structure	Steel beams and columns with metal roof deck supported by open-web steel joists and concrete slab	Fair
Facade	Wall Finish: CMU	Fair
Roof	Flat construction with metal finish	Fair
Interiors	Walls: Unfinished Floors: unfinished concrete Ceilings: Unfinished/exposed	Fair
Elevators	None	-
Plumbing	None	-

The canopy shade structure is supported by steel beams and columns with 8" concrete block walls at the back, all resting on a concrete slab. Notably, the exposed metal structure exhibits signs of rust, necessitating immediate repairs, the costs of which are included in the budget for immediate needs. The wash rack structure is due for a roof replacement in the near future and exterior wall painting for wash rack walls is recommended.

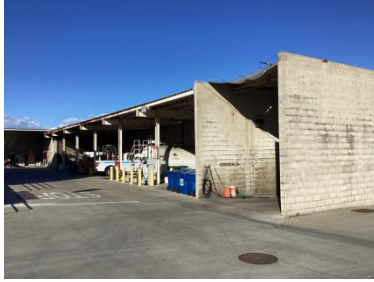
Exterior Walls in Poor condition.

any painted surface
Shade Structure A
Wash Bay

The paint finish is faded away due to use of pressure washers at wash rack. - AssetCALC ID: 7340676

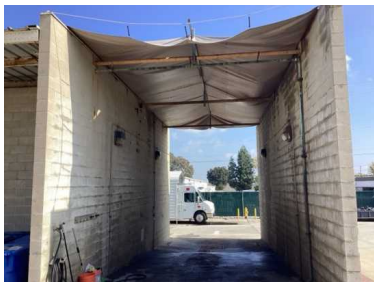
Roofing in Poor condition.

Metal
Shade Structure A
Wash Bay Only

A new roof covering is needed for the wash rack area. - AssetCALC ID: 7336612

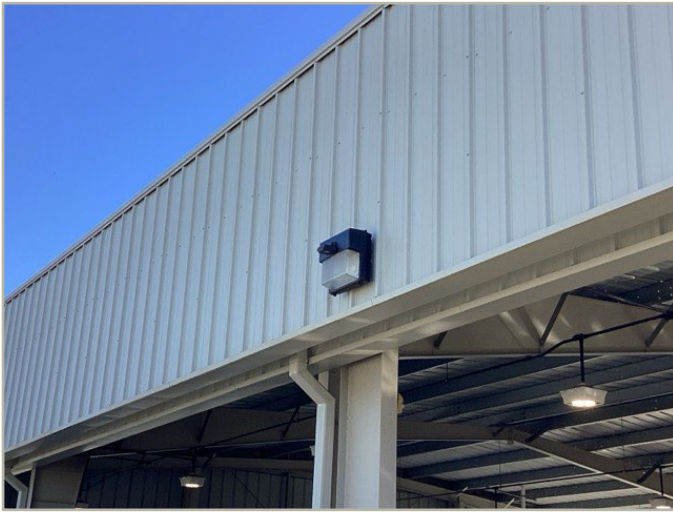
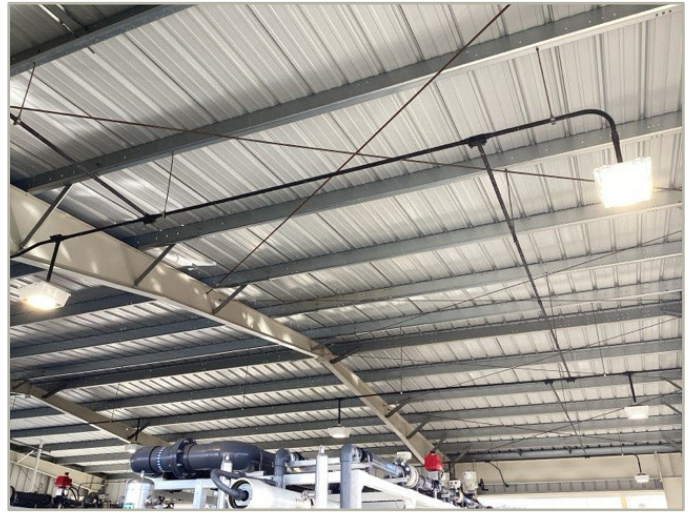
7. Well 9 Nano-Filtration Treatment Plant

Address	2175 East 28th Street, Signal Hill, CA 90755	
Constructed/Renovated	2017	
Building Area	4,189 SF	
Number of Stories	1 above grade	
<i>System</i>	<i>Description</i>	<i>Condition</i>
Structure	Steel beams & columns with metal roof deck supported by open-web steel joists and concrete slab	Good
Facade	Wall Finish: Metal	Good
Roof	Primary: Flat construction with metal finish	Good
Interiors	Floors: Unfinished concrete Ceilings: Unfinished/exposed	Good
Elevators	None	-

The structure is supported by steel beams and columns, all resting on a concrete slab and mat foundation. The canopy has an exposed ceiling with metal roofing. Overall, the architectural assets for this structure are relatively new and would only require typical lifecycle renewals.

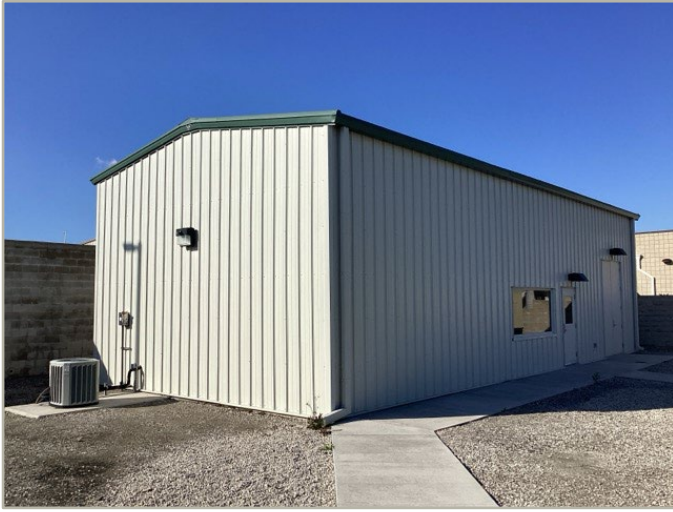
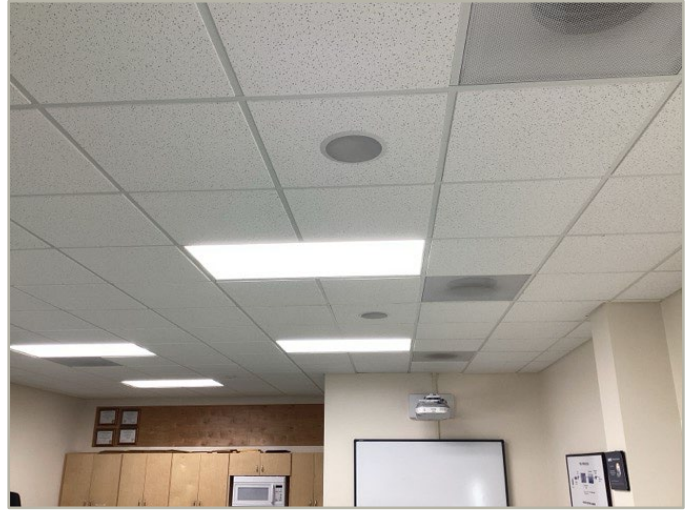
8. Well 9 Training

Address	2175 East 28th Street, Signal Hill, CA 90755	
Constructed/Renovated	2017	
Building Area	1,424 SF	
Number of Stories	1 above grade	
<i>System</i>	<i>Description</i>	<i>Condition</i>
Structure	Prefabricated metal building over concrete slab foundation	Good
Facade	Wall Finish: Metal siding Windows: Aluminum	Good
Roof	Flat construction with metal finish	Good
Interiors	Walls: Painted gypsum board Floors: Sealed concrete Ceilings: Suspended ceiling ACT	Fair
Elevators	None	-

The building was constructed in 2017 on a thick concrete slab foundation supporting a prefabricated metal building structure with hollow metal doors and an aluminum window. Overall, the architectural assets of the building are fairly new and in good condition. Typical lifecycle renewal repairs are recommended.

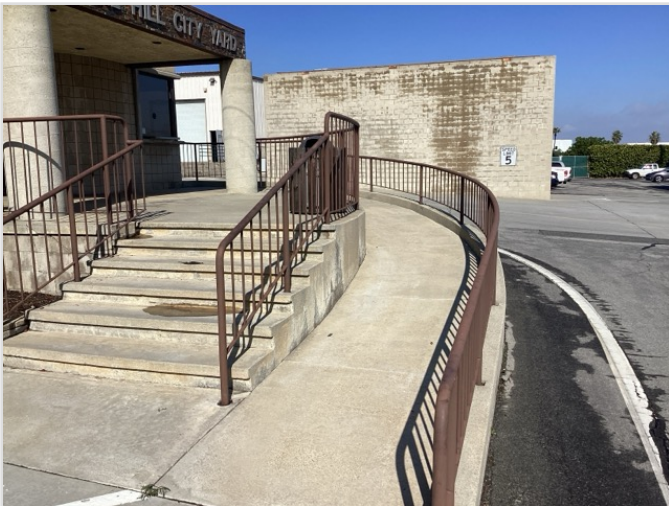
ACCESSIBLE RAMP

City Yard: Accessibility Issues				
Category	Major Issues (ADA study recommended)	Moderate Issues (ADA study recommended)	Minor Issues	None*
Parking			Main Parking Signage missing	
Exterior Accessible Route		Ramp landing has cracks		
Building Entrances		Door non compliant		
Interior Accessible Route		Door hardware non compliant		
Elevators	NA			
Public Restrooms			Sink width non compliant	
Kitchens/Kitchenettes			Sink clearance non compliant	
Playgrounds & Swimming Pools	NA			
Other	NA

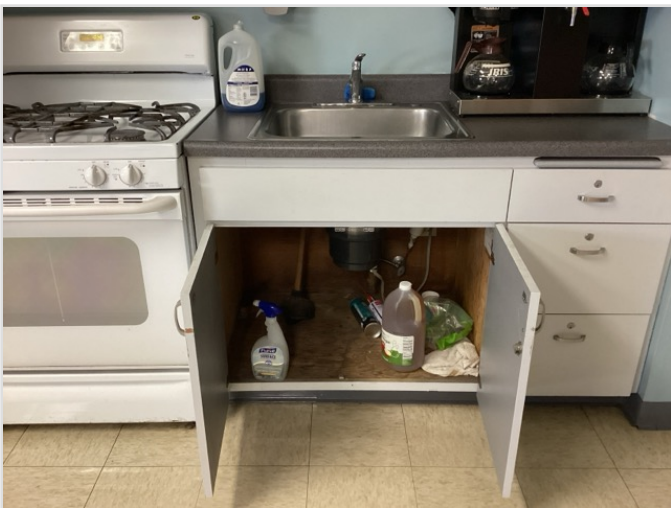
SINK CLEARANCE

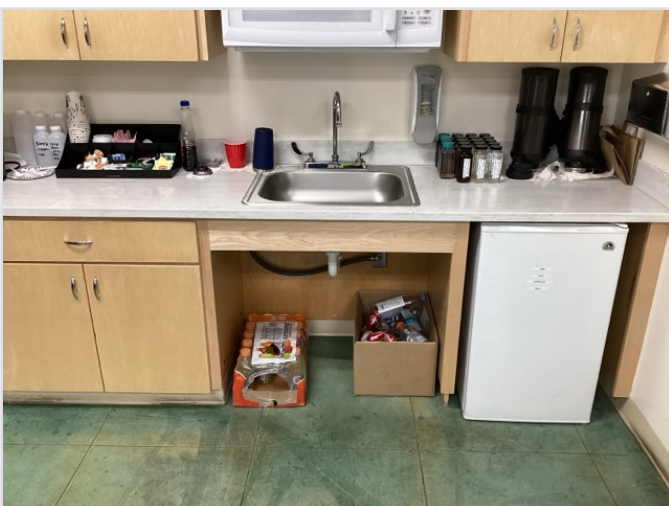
ACCESSIBLE ACCESS UNDER BASE CABINET

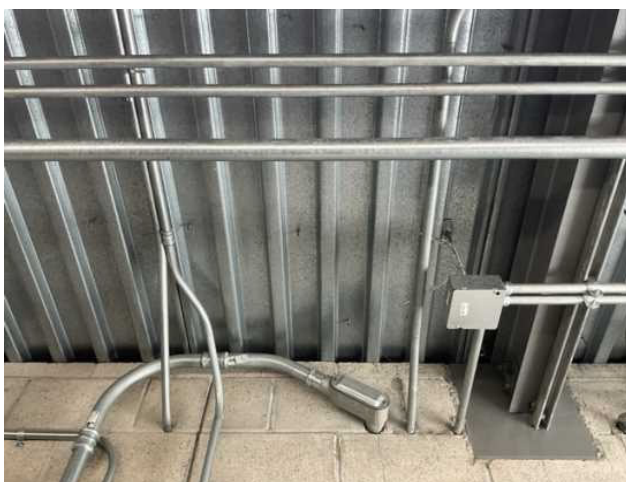
5 - STRUCTURAL PHOTO

Address	2745 Walnut Avenue, Signal Hill, CA 90755	
Constructed/Renovated	2012	
Building Area	28,620 SF	
Number of Stories	1 above grade	
<i>System</i>	<i>Description</i>	<i>Condition</i>
Structure	Masonry bearing walls with metal roof deck supported by open-web steel joists and concrete strip footing foundation system	Good
Facade	Primary Wall Finish :CMU Secondary Wall Finish: Stucco Windows: Aluminum	Fair
Roof	Primary: Flat construction with modified bituminous finish Secondary: Hip and Shed construction with metal finish	Poor
Interiors	Walls: Painted gypsum board, Wallpaper, Ceramic tile, Unfinished Floors: Carpet, Ceramic tile Ceilings: Painted gypsum board and ACT	Fair
Elevators	None	-

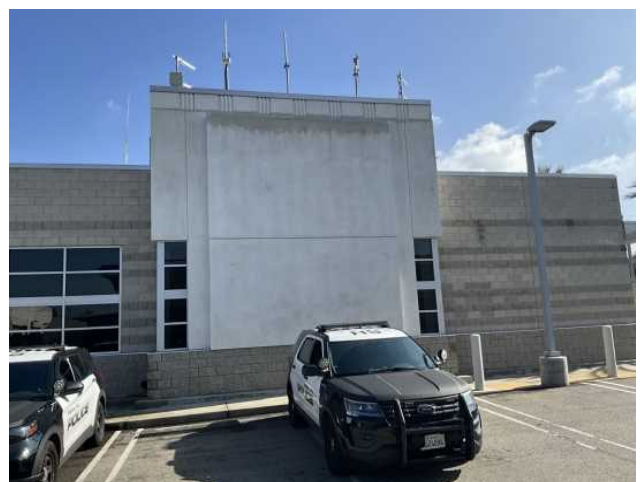
6 - EXTERIOR WALLS

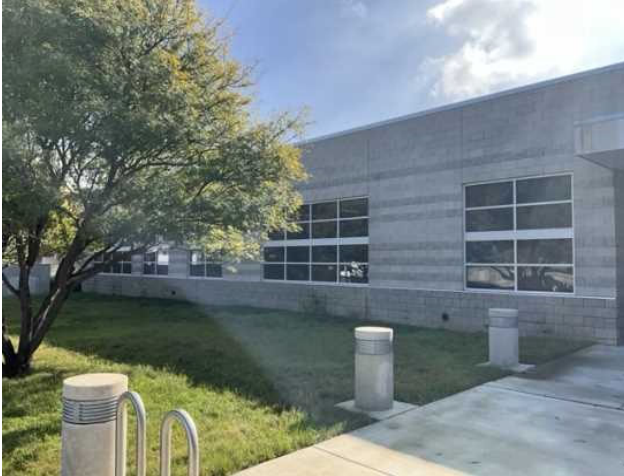
7 - BUILDING FACADE

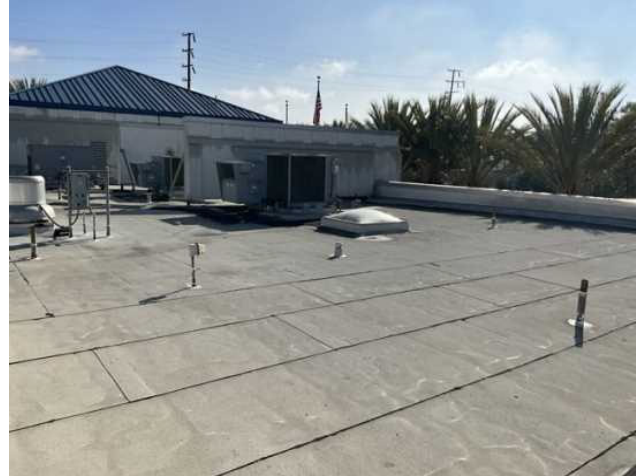
8 - ROOF

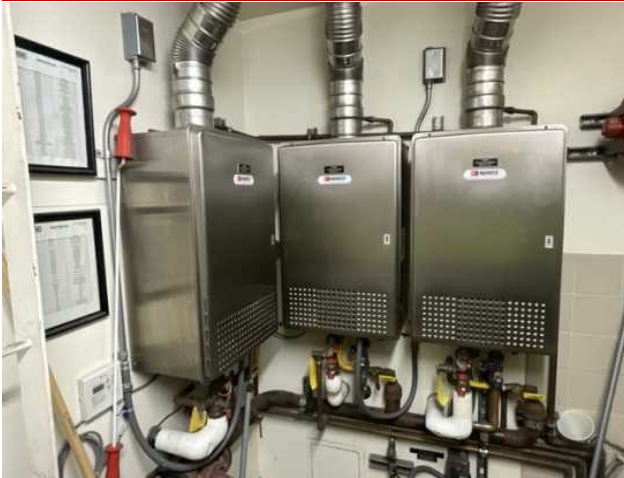
13 - DOMESTIC HOT WATER SUPPLY
