FACILITY CONDITION ASSESSMENT

FCA and Master Plan Study

City Hall
2175 Cherry Avenue
Signal Hill, CA 90755

October 1, 2024

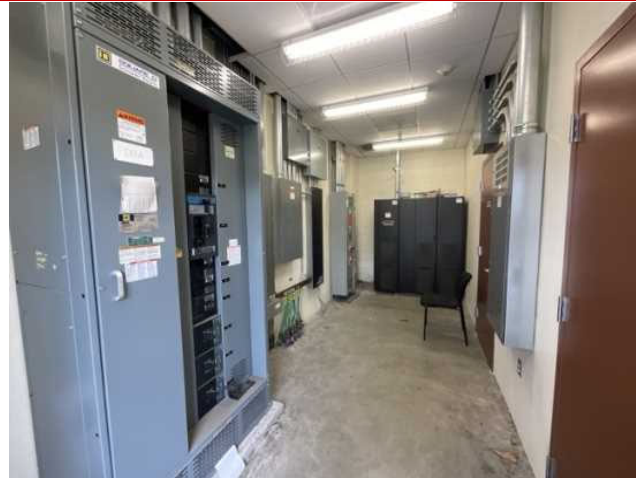
14 - MAIN ELECTRICAL ROOM

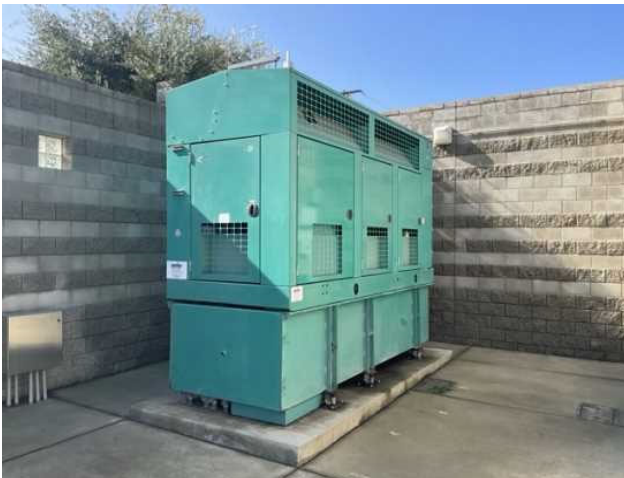
15 - EMERGENCY GENERATOR

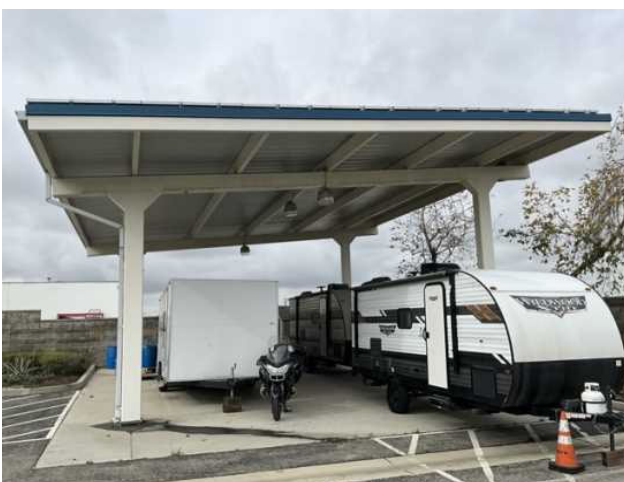
17 - SHADE STRUCTURE

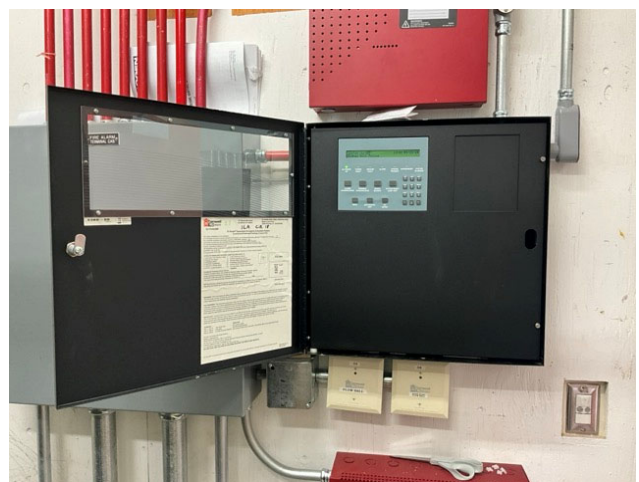
18 - FIRE ALARM PANEL

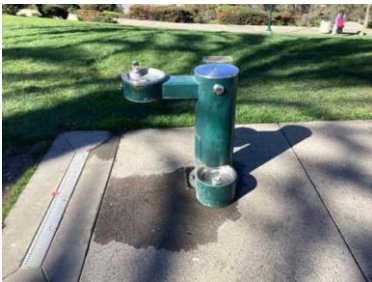
Plumbing leaks, water pressure, and clogging/backup problems were brought up by facility maintenance personnel. - AssetCALC ID: 7348712

Drinking Fountain in Poor condition.

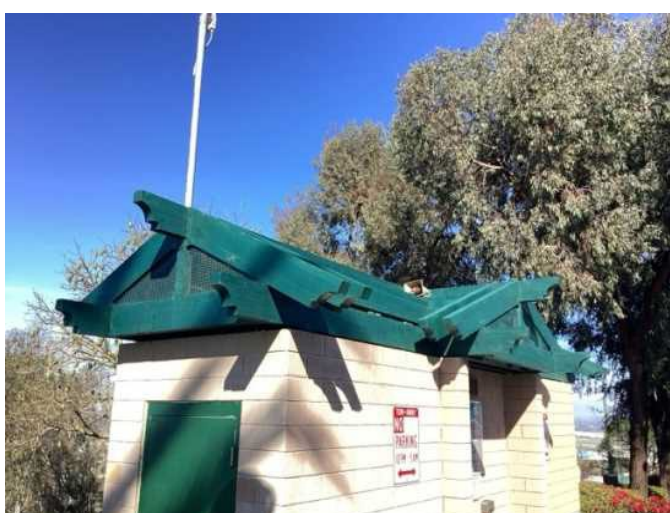
5 - ROOF OVERVIEW

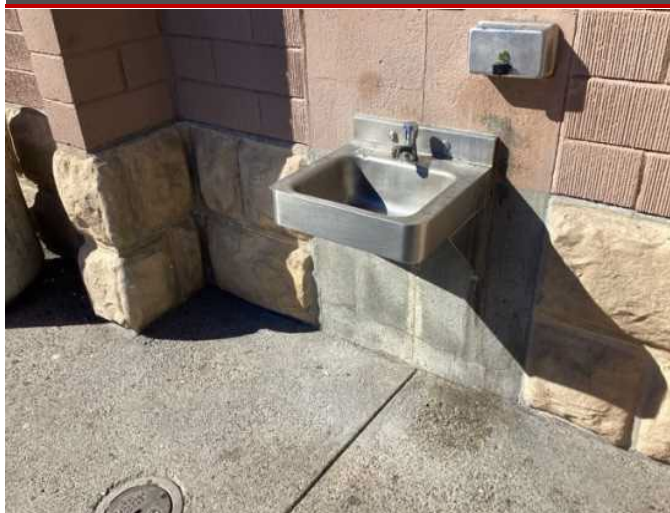
7 - SINK, FAUCET HANDLES AND ACCESSORIES

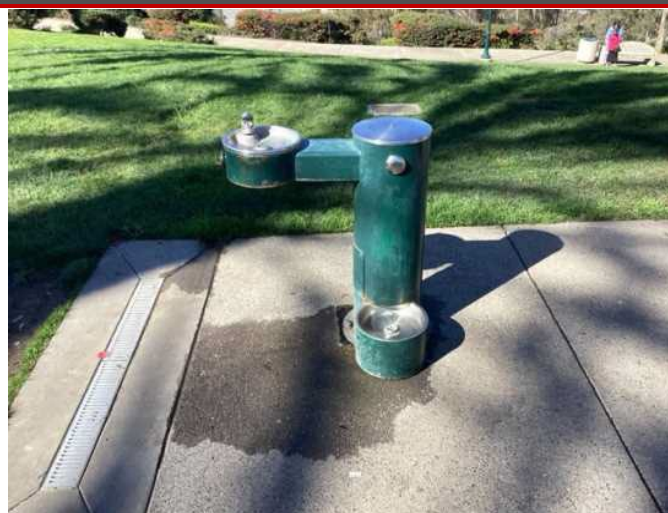
8 - DRINKING FOUNTAIN

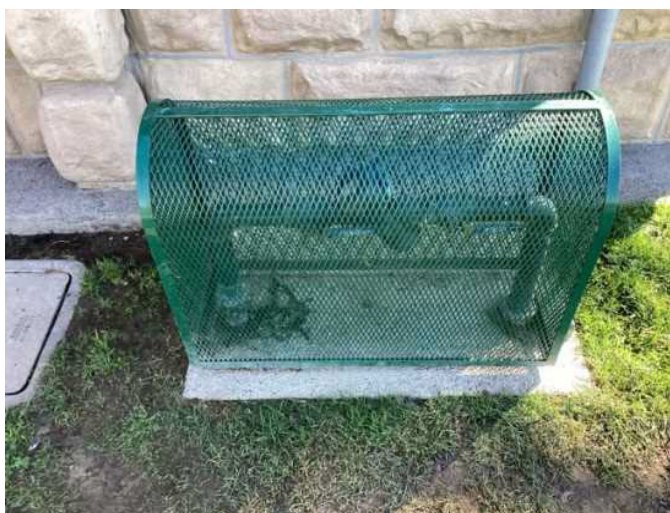
9 - BACKFLOW PREVENTER

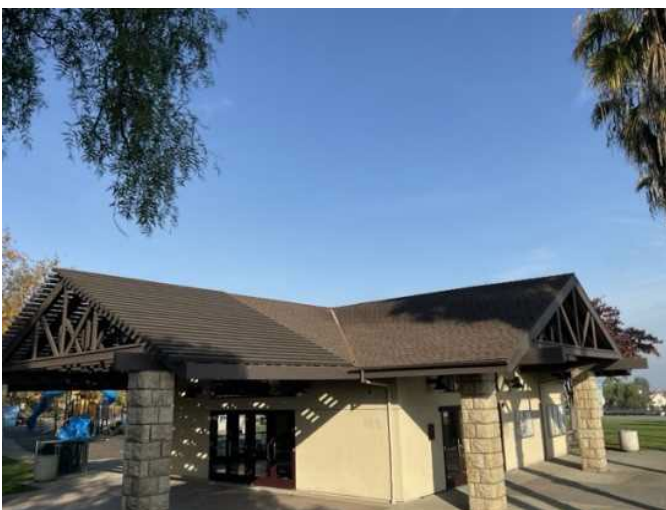
5 - ROOF OVERVIEW

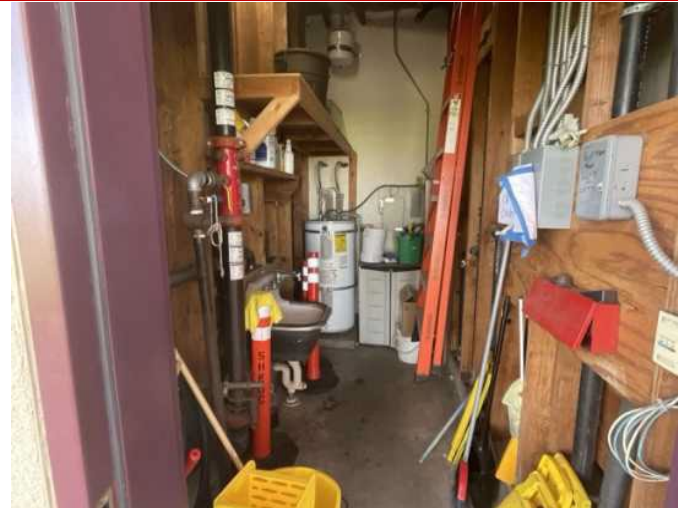
8 - FIRE RISER AND DOMESTIC HOT WATER

The plumbing system is adequate to serve the facility. The domestic hot water heater at the community center was replaced in 2012 and is adequate.

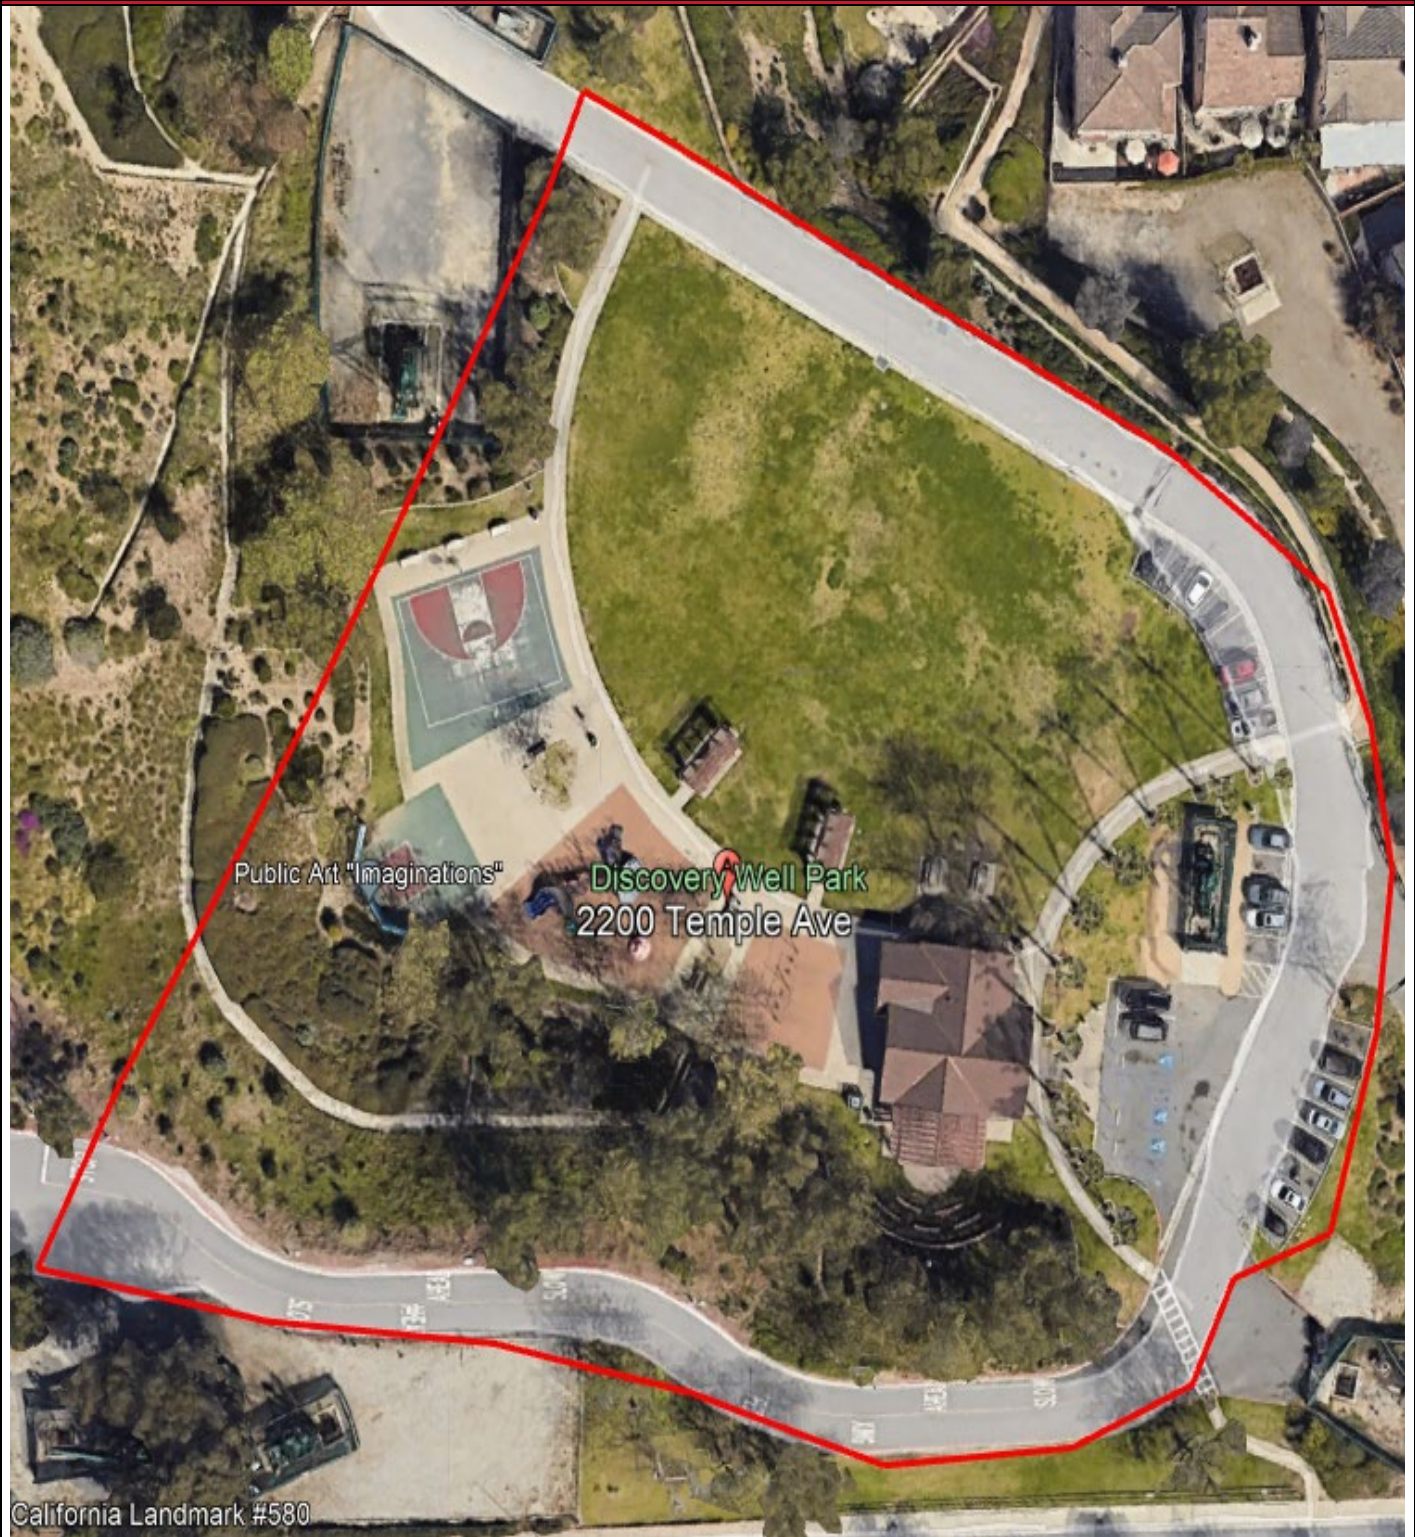
Site Plan

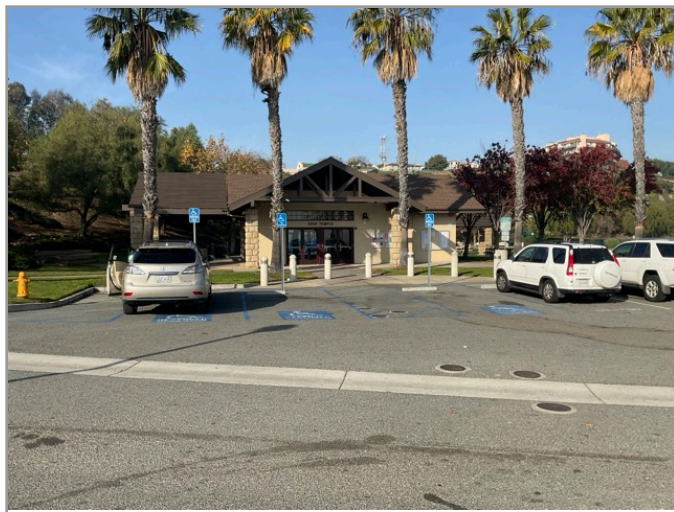
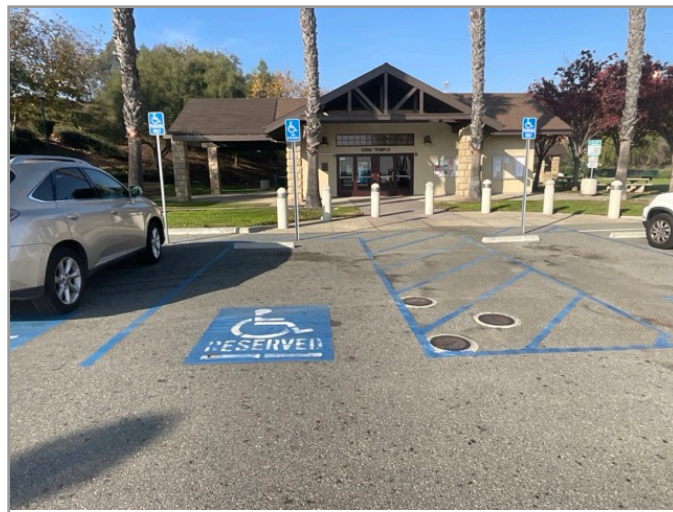
OVERVIEW OF ACCESSIBLE PARKING AREA

CLOSE-UP OF STALL

Question		Yes	No	NA	Comments
1	Does the required number of standard ADA designated spaces appear to be provided ?	✗			
2	Does the required number of van-accessible designated spaces appear to be provided ?	✗			
3	Are accessible spaces on the shortest accessible route to an accessible building entrance ?	✗			
4	Does parking signage include the International Symbol of Accessibility ?	✗			
5	Does each accessible space have an adjacent access aisle ?	✗			
6	Do parking spaces and access aisles appear to be relatively level and without obstruction ?	✗

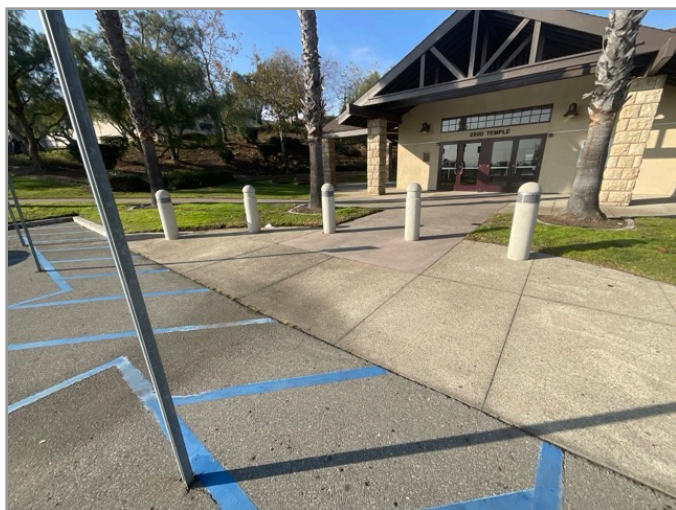
ACCESSIBLE PATH

2ND PATHWAY

Question		Yes	No	NA	Comments
1	Is an accessible route present from public transportation stops and municipal sidewalks on or immediately adjacent to the property ?	✗			
2	Does a minimum of one accessible route appear to connect all public areas on the exterior, such as parking and other outdoor amenities, to accessible building entrances ?	✗			
3	Are curb ramps present at transitions through raised curbs on all accessible routes?	✗			
4	Do curb ramps appear to have compliant slopes for all components ?	✗			
5	Do ramp runs on an accessible route appear to have compliant slopes ?			✗	
6	Do ramp runs on an accessible route appear to have a compliant rise and width ?			✗

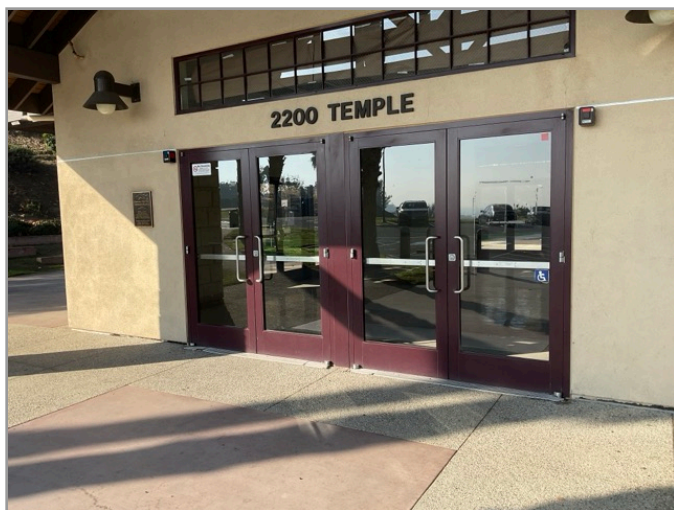
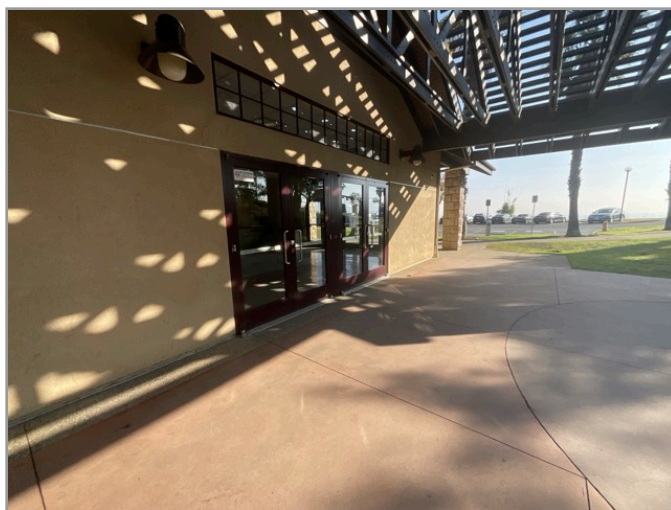
ACCESSIBLE ENTRANCE

ADDITIONAL ENTRANCE

Question		Yes	No	NA	Comments
1	Do a sufficient number of accessible entrances appear to be provided ?	✗			
2	If the main entrance is not accessible, is an alternate accessible entrance provided?	✗			
3	Is signage provided indicating the location of alternate accessible entrances ?	✗			
4	Do doors at accessible entrances appear to have compliant maneuvering clearance area on each side ?	✗			
5	Do doors at accessible entrances appear to have compliant hardware ?	✗			
6	Do doors at accessible entrances appear to have a compliant clear opening width ?	✗

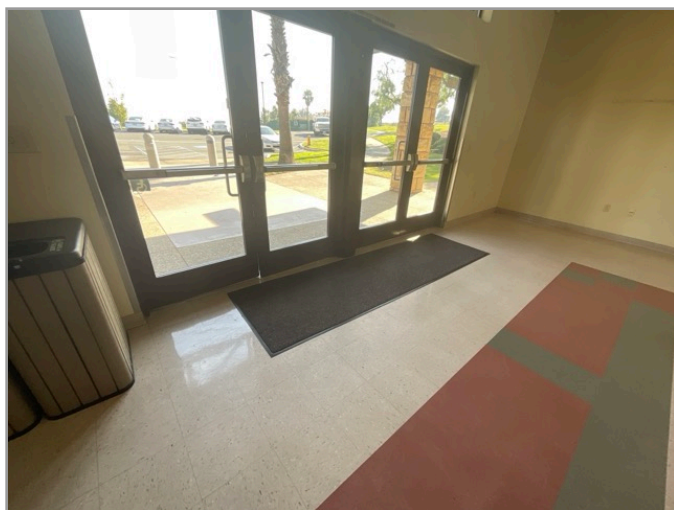
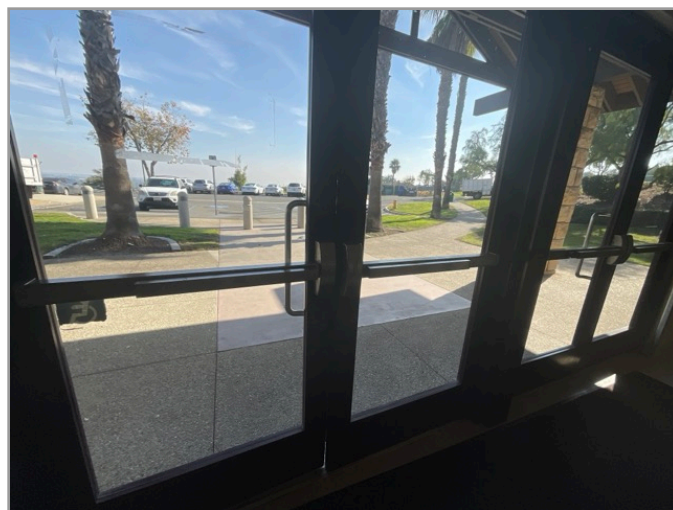
ACCESSIBLE INTERIOR PATH

DOOR HARDWARE

Question		Yes	No	NA	Comments
1	Does an accessible route appear to connect all public areas inside the building ?	✗			
2	Do accessible routes appear free of obstructions and/or protruding objects ?	✗			
3	Do ramps on accessible routes appear to have compliant slopes ?			✗	
4	Do ramp runs on an accessible route appear to have a compliant rise and width ?			✗	
5	Do ramps on accessible routes appear to have compliant end and intermediate landings ?			✗	
6	Do ramps on accessible routes appear to have compliant handrails ?			✗

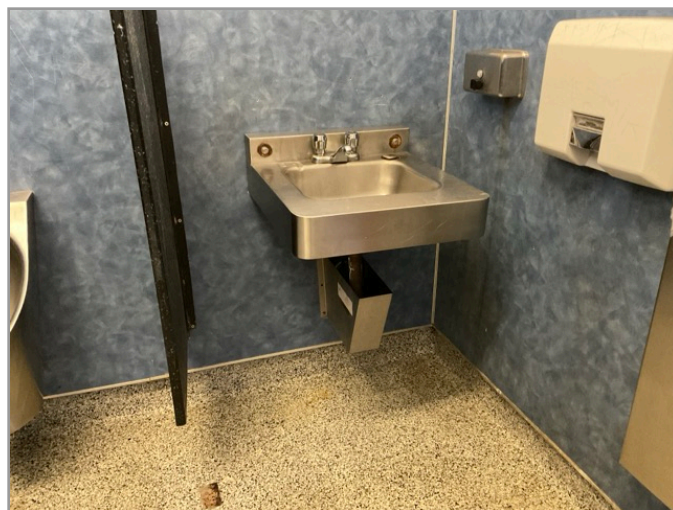
TOILET STALL OVERVIEW

SINK, FAUCET HANDLES AND ACCESSORIES

Question		Yes	No	NA	Comments
1	Do publicly accessible toilet rooms appear to have a minimum compliant floor area ?	✗			
2	Does the lavatory appear to be mounted at a compliant height and with compliant knee area ?	✗			
3	Does the lavatory faucet have compliant handles ?	✗			
4	Is the plumbing piping under lavatories configured to protect against contact ?	✗			
5	Are grab bars provided at compliant locations around the toilet ?	✗			
6	Do toilet stall doors appear to provide the minimum compliant clear width ?	✗

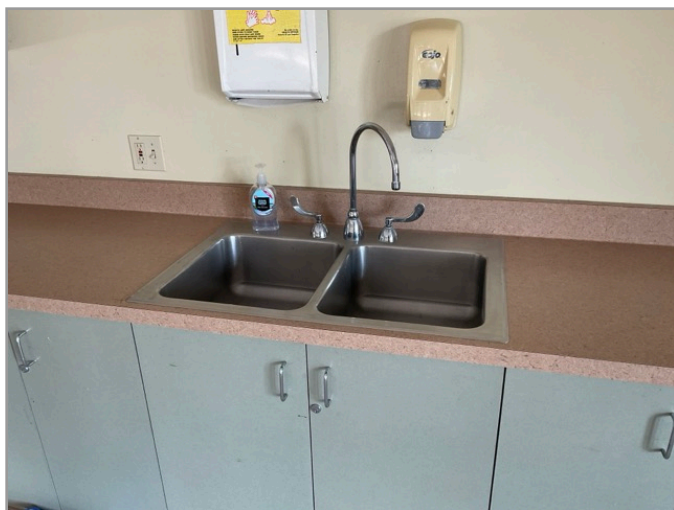
SINK CLEARANCE

Question		Yes	No	NA	Comments
1	Do kitchens/kitchenettes appear to have a minimum compliant path of travel or area of maneuverability ?	✗			
2	Are the appliances centered for a parallel or forward approach with adequate clear floor space ?	✗			
3	Is there an accessible countertop/preparation space of proper width and height ?	✗			
4	Is there an accessible sink space of proper width and height ?	✗			
5	Does the sink faucet have compliant handles ?	✗			
6	Is the plumbing piping under the sink configured to protect against contact ?			✗

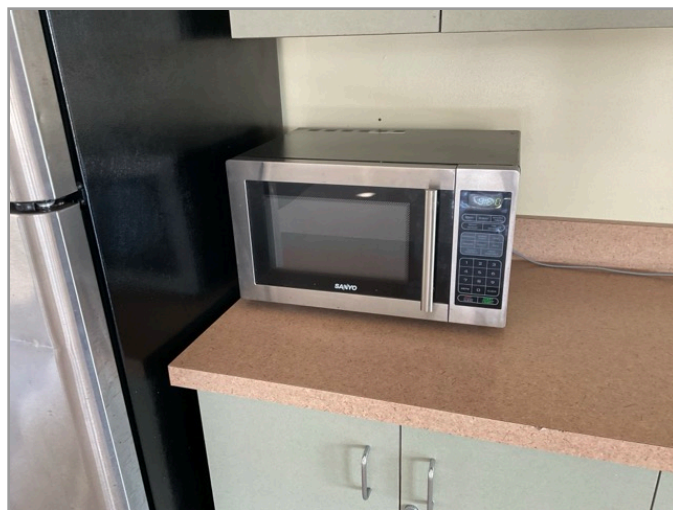
KITCHEN ACCESSORIES

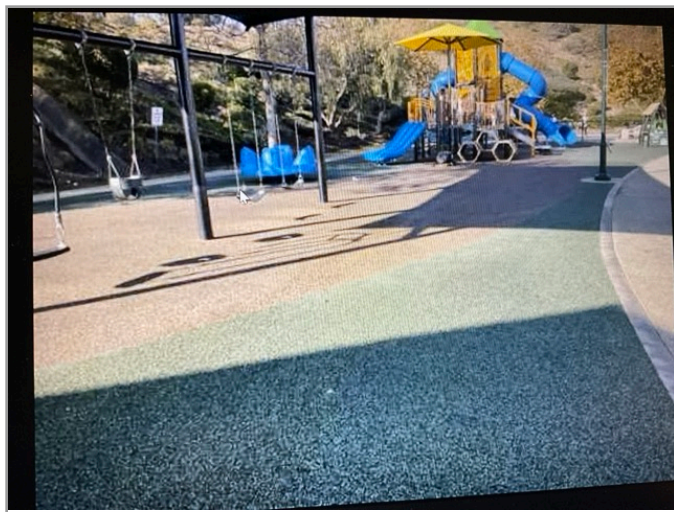
ACCESSIBLE ROUTE TO PLAYGROUND

Question		Yes	No	NA	Comments
1	Is there an accessible route to the play area / s?	✗			
2	Has the play area been reviewed for accessibility ?	✗			
3	Are publicly accessible swimming pools equipped with an entrance lift ?			✗

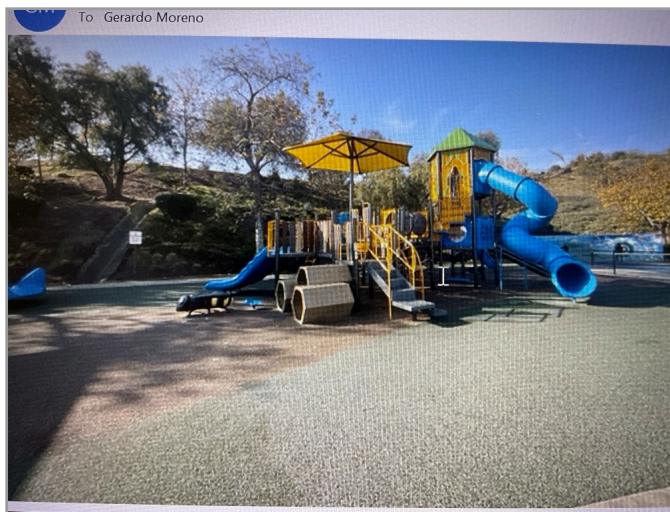
OVERVIEW OF PLAYGROUND

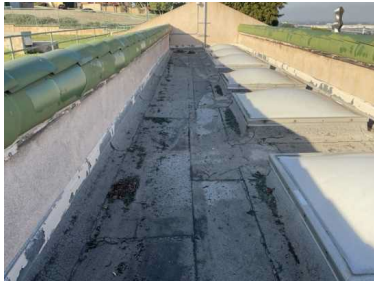
**Roofing in Poor condition.**

Built-Up
Pump Station
Roof

Uniformat Code: B3010
Recommendation: **Replace in 2024**

Bumps/blisters on some sections of the roof. - AssetCALC ID: 7215522

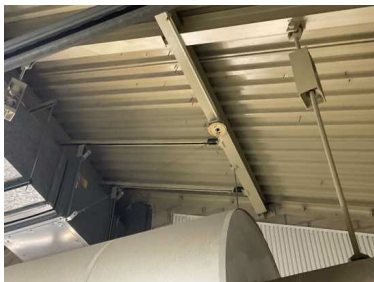
**Fire Alarm Devices in Failed condition.**

Smoke Detector
Pump Station
Throughout building

Uniformat Code: D7050
Recommendation: **Replace/Install in 2024**

Broken smoke detectors - AssetCALC ID: 7215491

The existing fans are original construction, with no issues observed at the time of the visit. The electrical installation and equipment are original construction, with the generator performing as designed. For the plumbing system, the motorized control valves were renovated in 2023. The provided fire protection for the facility is very weak given the smoke detectors are broken. Immediate attention is needed to restore this annunciator device.

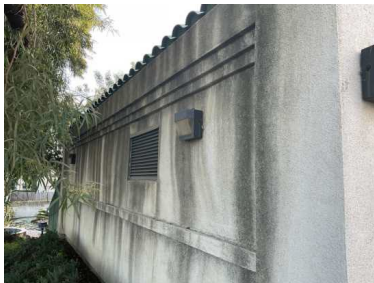
**Exterior Walls in Poor condition.**

Stucco, Prep & Fog Coat or Paint
Storage Building
Building Exterior

Uniformat Code: B2010
Recommendation: **Prep & Fog Coat or Paint in 2026**

The stucco wall system requires paint renewal soon. - AssetCALC ID: 7215489

The roof is a clay tile roofing system, with a stucco exterior wall finish. The stucco wall system shows water staining and should be cleaned up and painted soon.

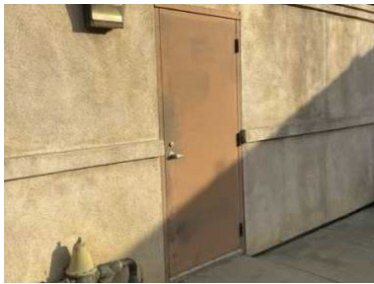
**Exterior Door in Poor condition.**

Steel, any type
Storage Building

Uniformat Code: B2050
Recommendation: **Refinish in 2024**

The exterior door finish is in poor condition. - AssetCALC ID: 7349431

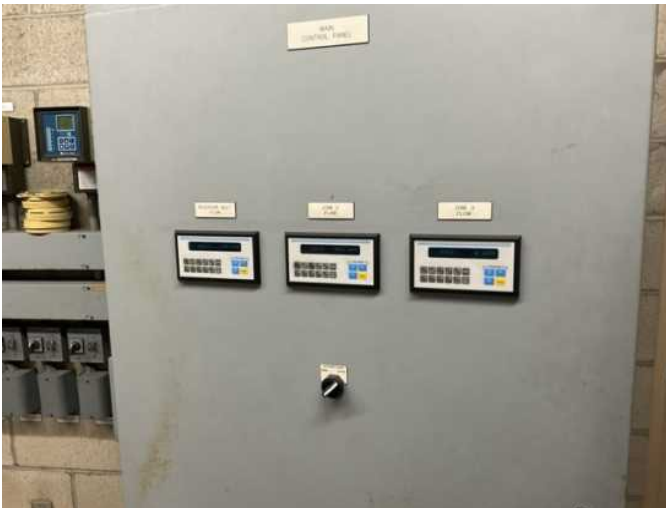
9 - PUMP STATION - COMMUNICATION PANEL

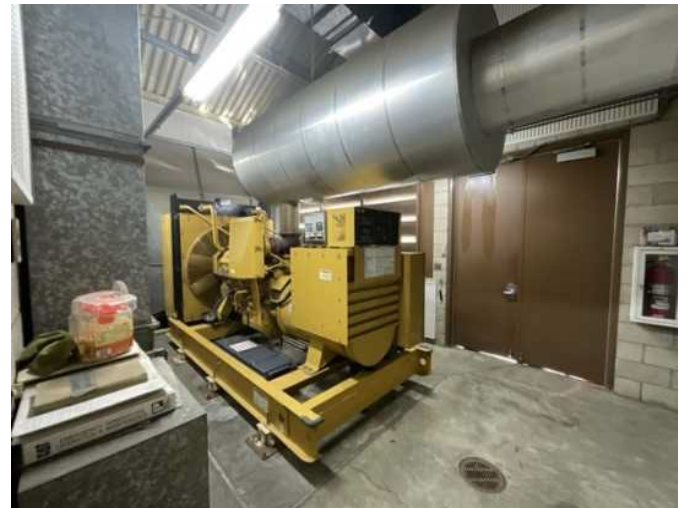
10 - PUMP STATION - GENERATOR ROOM

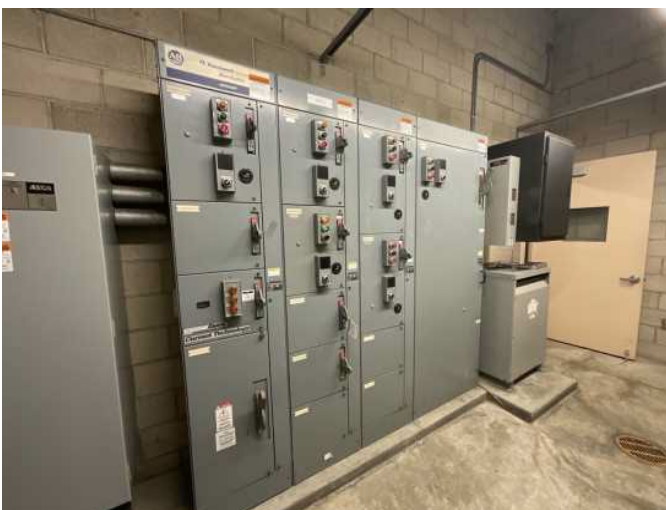
11 - PUMP STATION - MOTOR CONTROL CENTER

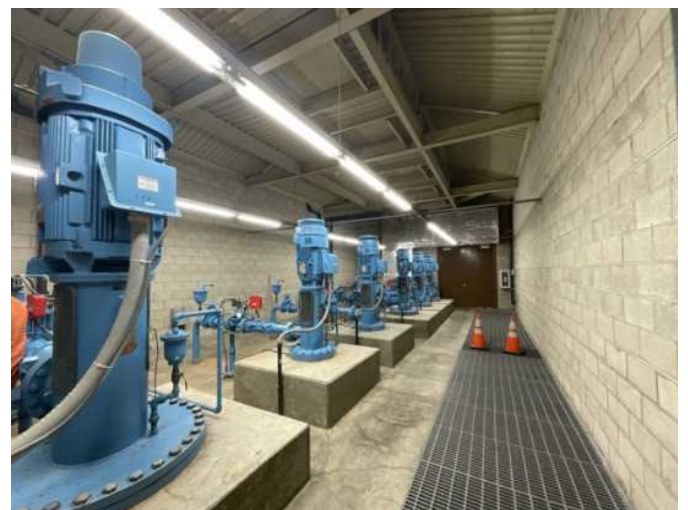
12 - PUMP STATION - PUMP ROOM

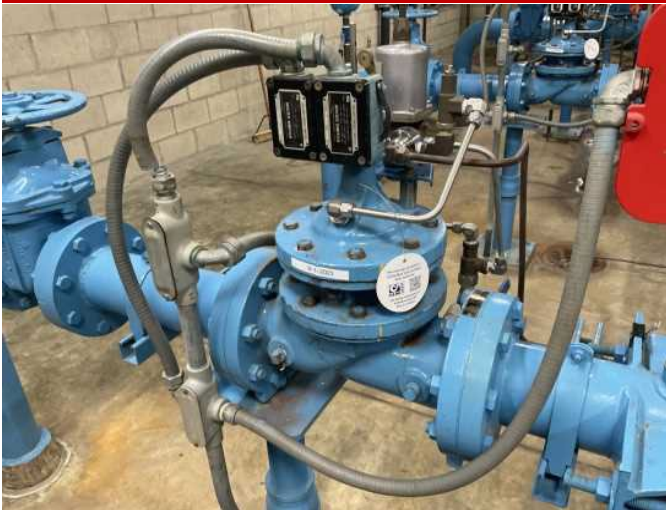
13 - PUMP STATION – MOTORZD CNTRL VALVES

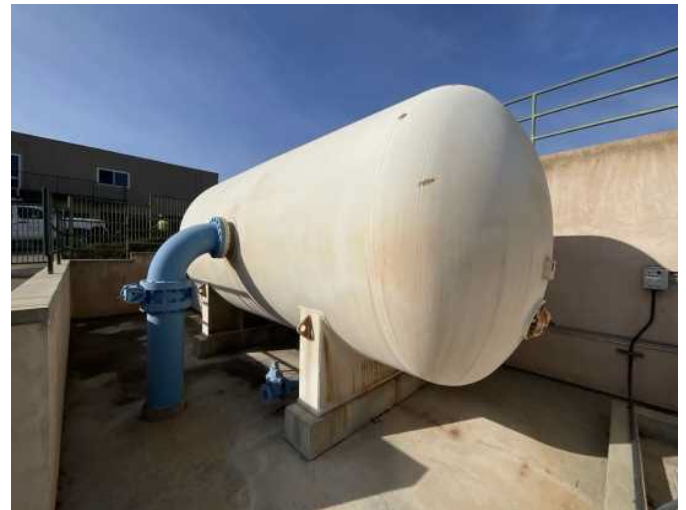
16 - WATER STORAGE TANK

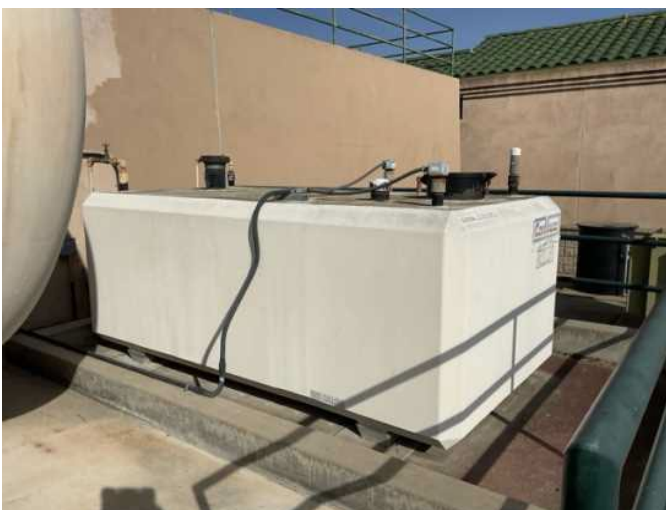
17 - FUEL STORAGE TANK

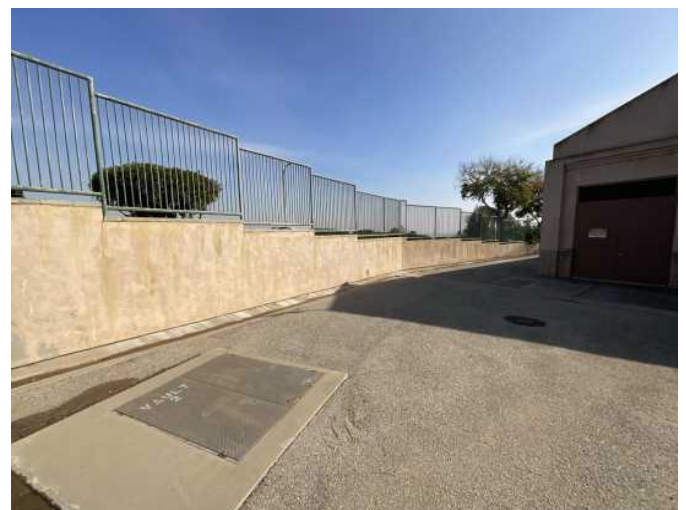
18 - RETAINING WALL

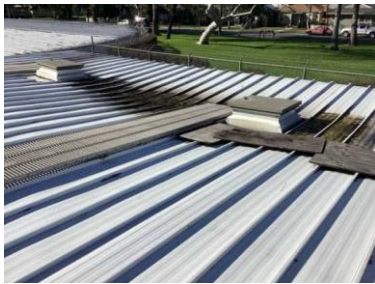
Recommended Follow-up Study: in Failed condition.

Building Envelope, Roof
Sand Basin Building
Sand Basin West Roof

Significant sagging and ponding of water were noted on the west half of the roof. It is recommended to conduct a detailed study to assess the extent of damage to the metal roof and potentially the underlying structure. - AssetCALC ID: 7357404

Location	UF	Description	Cond	Plan Type	Cost
Gundry Pump Station / Sand Basin Building	P2032	Architectural Study, Building Envelope, Roof, Evaluate/Report	Failed	Performance/Integrity	\$11,200
Gundry Pump Station / Sand Basin Building	B3015	Roofing, any type, Repairs per Man-Day, Repair	Failed	Performance/Integrity	\$8,800
TOTAL (2 items)					\$20,000

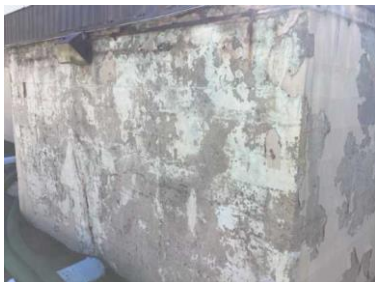
Exterior Walls in Poor condition.

any painted surface
Sand Basin Building
Building Exterior

Some portions of the exterior wall paint have deteriorated. - AssetCALC ID: 7357447

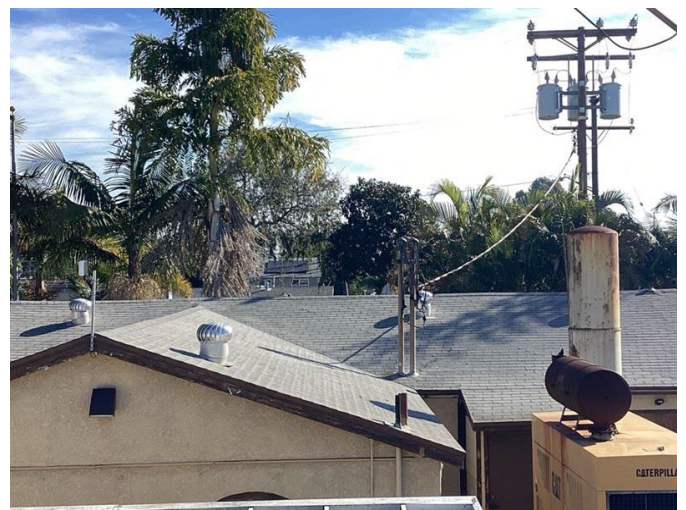
12 - GUNDRY PUMP STATION ROOF OVERVIEW

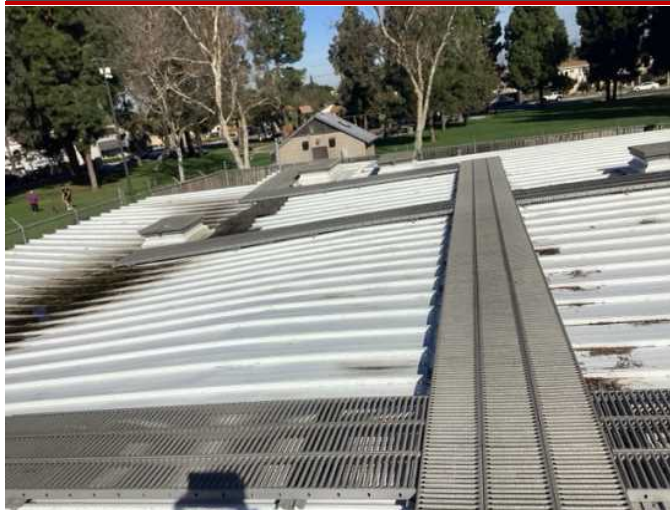
13 - SAND BASIN ROOF OVERVIEW

Significant sagging and ponding of water were noted on the west half of the roof. Repair the metal roof and provide proper sloping to avoid ponding. - AssetCALC ID: 7359381

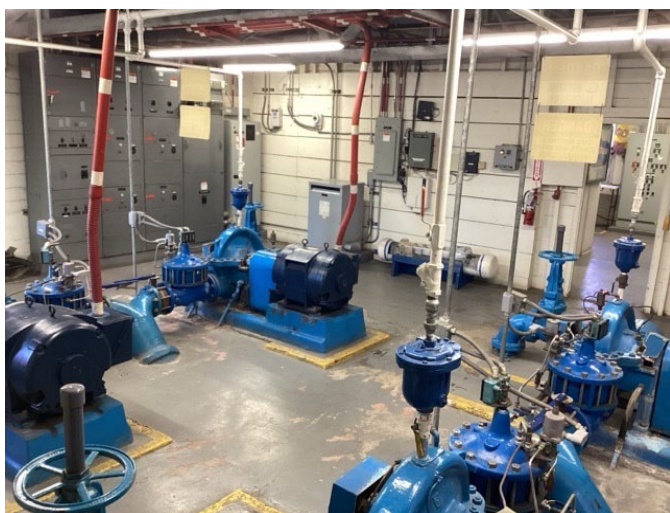
15 - GUNDRY PUMP STATION MOTORS AND PUMP

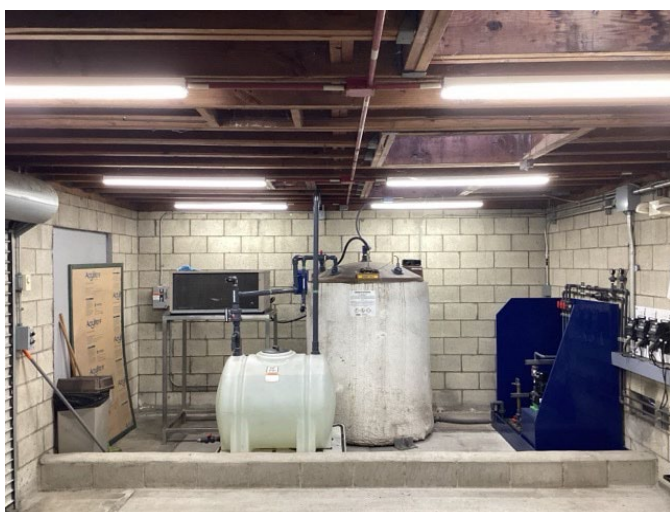
17 - GUNDRY PUMP STATION AMMONIA ROOM

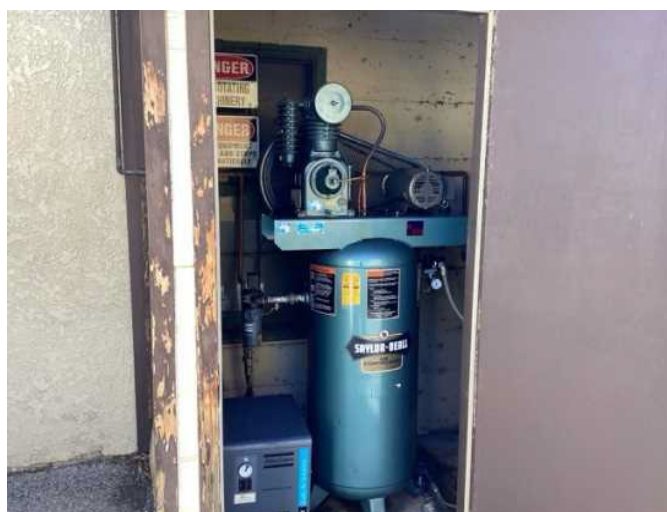
18 - GUNDRY PUMP STATION AIR COMPRESSOR

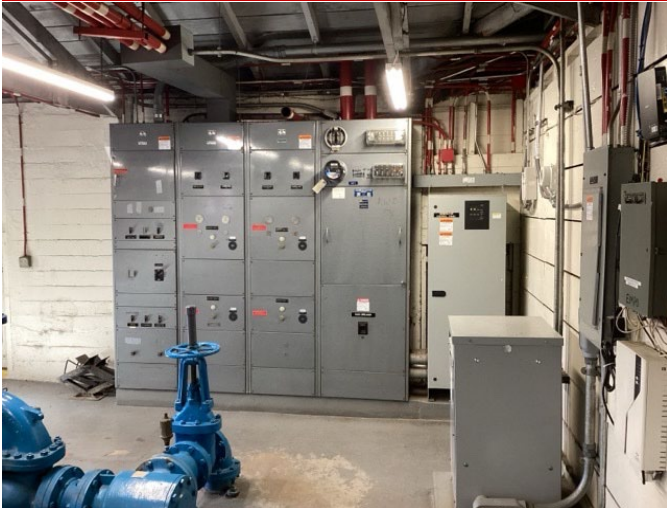
19 - GUNDRY PUMP STATION ELECTRICAL

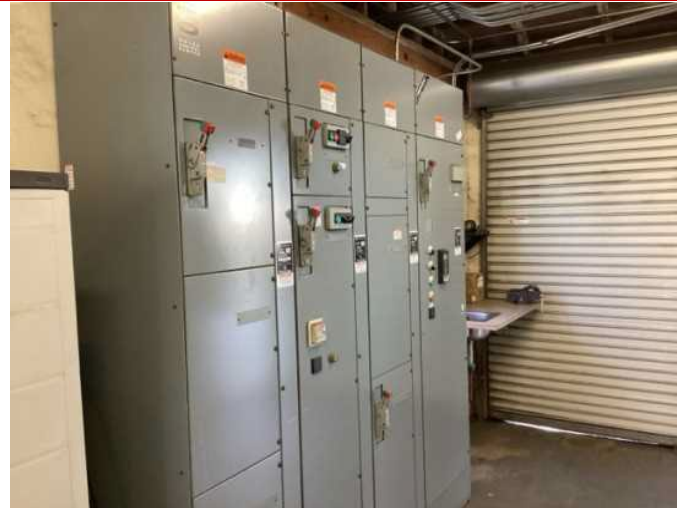
20 - GUNDRY PUMP MOTOR CONTROL CENTER

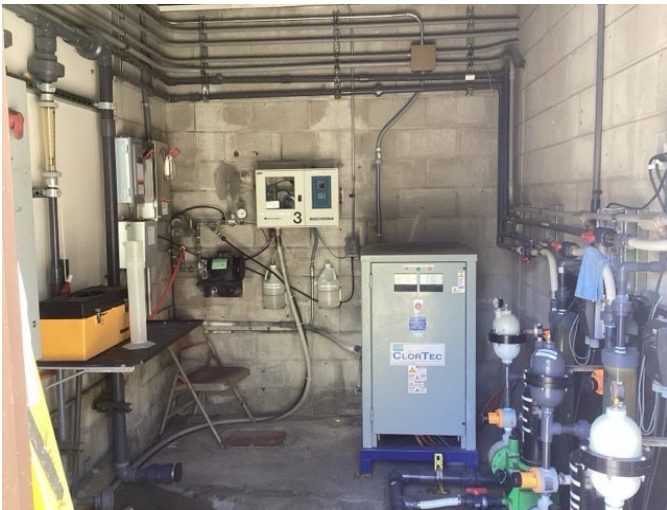
21 - SAND BASIN CHLORINE PUMP ROOM

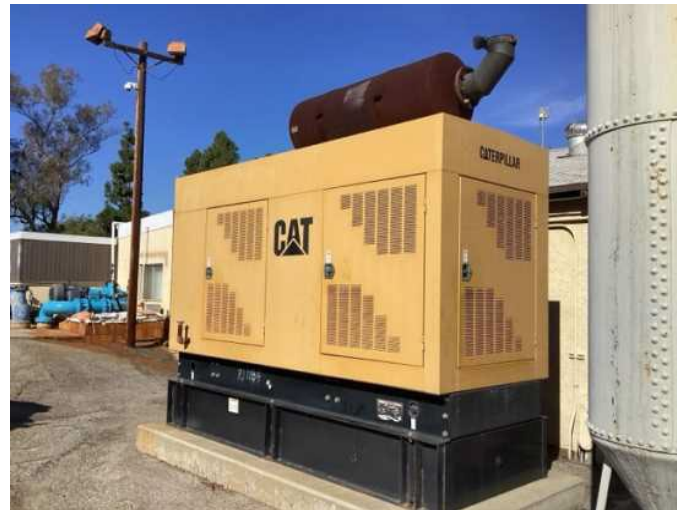
22 - GUNDRY PUMP STATION GENERATOR

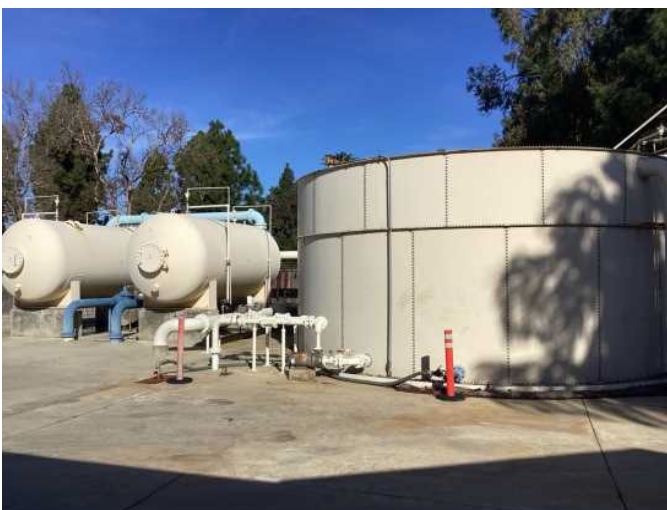
23 - GUNDRY PUMP STATION STORAGE TANK

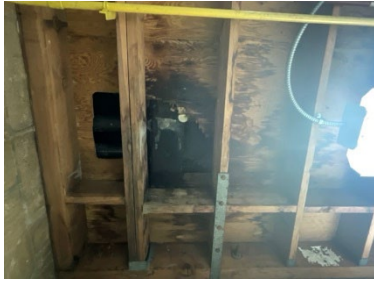
Roof Sheathing in Poor condition.

Plywood
Well 7
Roof

Water intrusion observed at roof sheathing. Replace sheathing and patch roof. - AssetCALC ID: 7338286

Location	UF Code	Description	Condition	Plan Type	Cost
Well 7	B1022	Roof Sheathing, Plywood, Replace	Poor	Performance/Integrity	\$100
Well 7	C2057	Ceiling Finishes, any flat surface, Prep & Paint	Poor	Performance/Integrity	\$2,900
Well 7	B3015	Roofing, Single-Ply Membrane, TPO/PVC, Replace	Poor	Performance/Integrity	\$22,300
TOTAL (3 items)					\$25,300

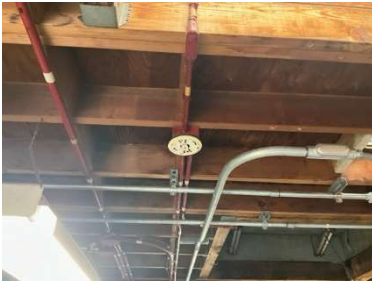
Fire Alarm Devices in Failed condition.

Smoke Detector
Well 10
Mechanical room

Smoke detector missing. - AssetCALC ID: 7342013

Location	UF	Description	Cond	Plan Type	Cost
Well 10	D7051	Fire Alarm Devices, Smoke Detector, Install	Failed	Safety	\$300
Well 10	B3065	Roof Hatch, Metal, Replace	Failed	Performance/Integrity	\$2,100
TOTAL (2 items)					\$2,400

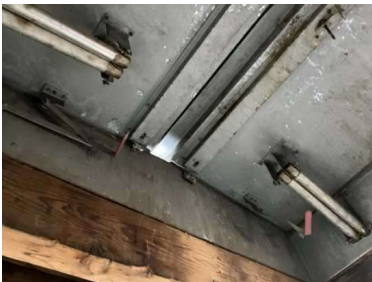
Roof Hatch in Failed condition.

Metal
Well 10
Roof

Water leaks reported with observed holes in hatch door. - AssetCALC ID: 7340994

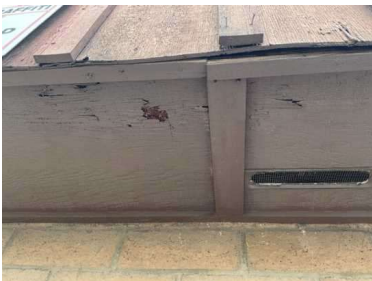
Soffit in Poor condition.

Wood
Well 10
Building exterior

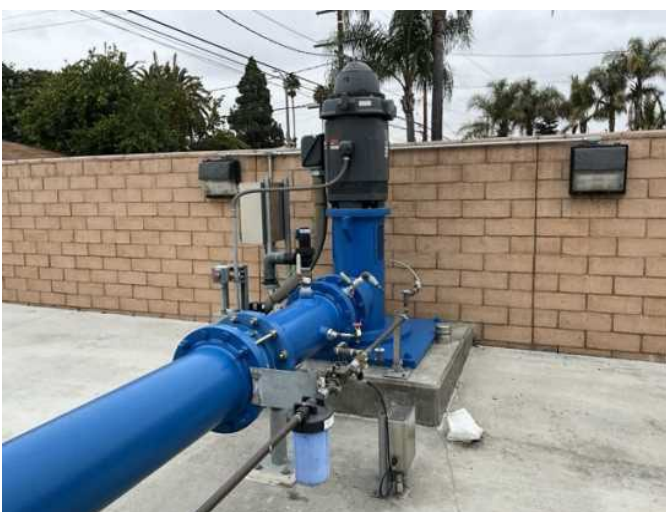
5 - NEW PLUMBING ASSET
