THE COURTYARD  
VIEW ANALYSIS  
August 2024

# The Courtyard – View Analysis

## Individual Narrative Report

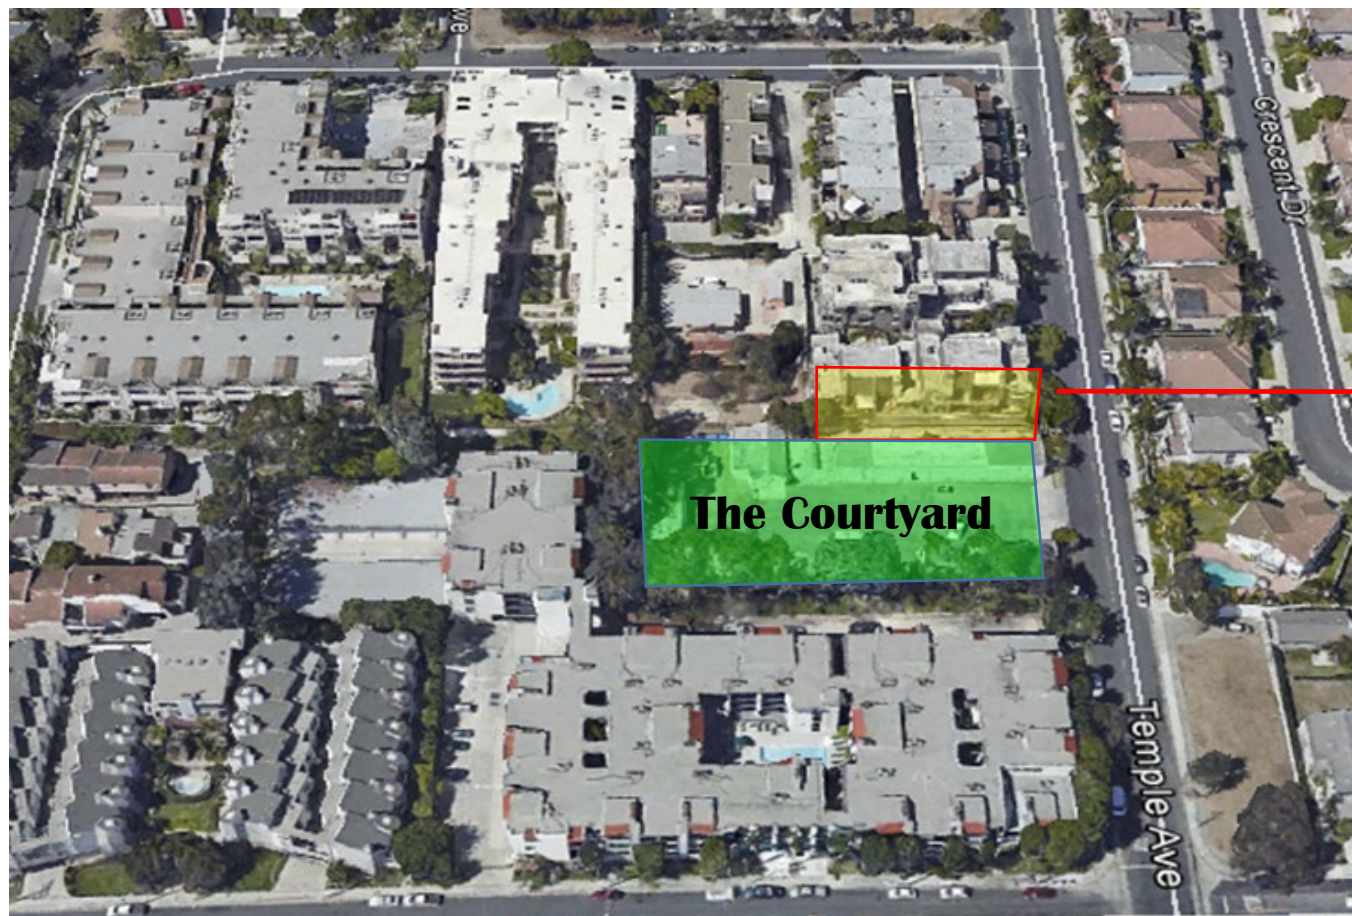
1957 Temple  
Unit 101  
Unit 102

This report summarizes the visual impacts of the proposed project located at 1933 Temple Ave. and the views of two neighbors located at 1957 Temple Ave, respectively Units 101 and Unit 102 located at 2744 E. 20th St.
